GEOWEB®

DIKE EMBANKMENT STABILIZATION

LNG ENERGY PROVIDER
Northeast US

3D Soil Confinement System Repairs Eroded Dikes Protecting LNG Storage Tanks

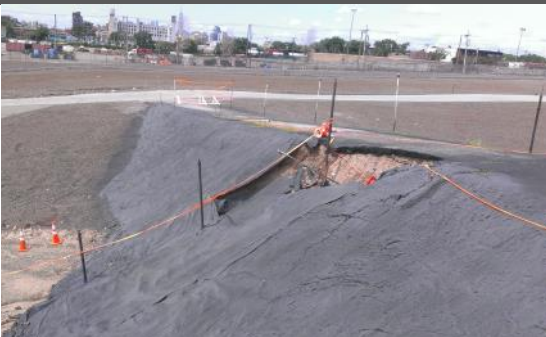
Degraded Original Asphalt Cover

To repair 100,000 sf (9,300 sm) of eroding primary and secondary dikes around a Liquid Natural Gas (LNG) storage tank. The original asphalt cover had deteriorated along the face of the dike largely due to expansion and contraction issues. A slope adjacent to an access roadway showed significant degradation caused by pavement cracks in the road that allowed water to penetrate the soil below the asphalt and create large holes in the slope.

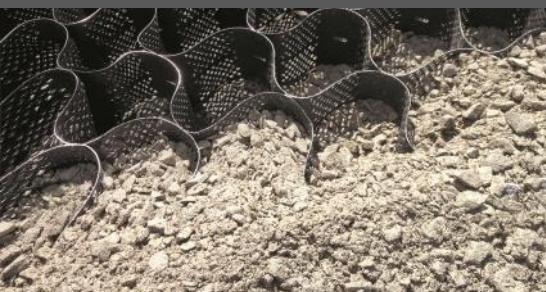
GEOWEB® Confinement System

To begin the slope rehabilitation of the primary dike, the existing asphalt cover was removed and the surface graded to remove any rills and depressions. Additional fill was added where necessary to level out the slope surface. A non-woven geotextile, followed by Presto's GEOWEB® 3D Soil Confinement System (GW30V6 mid-size cell, 6 in (150 mm)) depth was installed over the slope.
