## Peabody Coal High Flow Channel Lining Project ShearForce10 Hybrid-Turf Instant Armor Mat

## Peabody Coal Channel Project Details

#### Peabody Coal – ShearForce10 Instant Armor Mat Field Trial

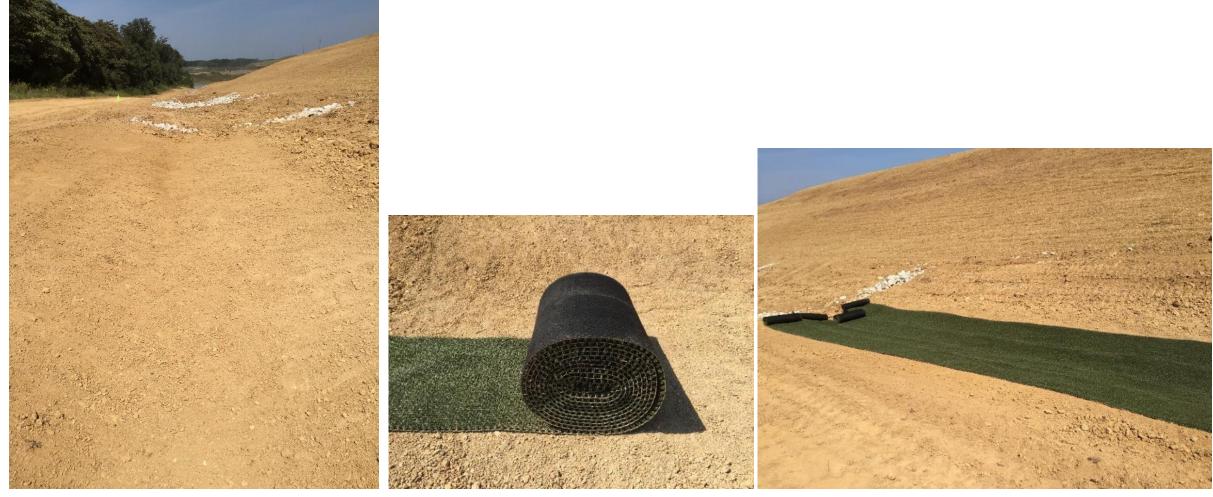
ShearForce10 Installed over cool season grass mix in high flow channel at the base of an overburden cap on September 10, 2019. Objective: Evaluate potential as rock riprap replacement in high flow areas.

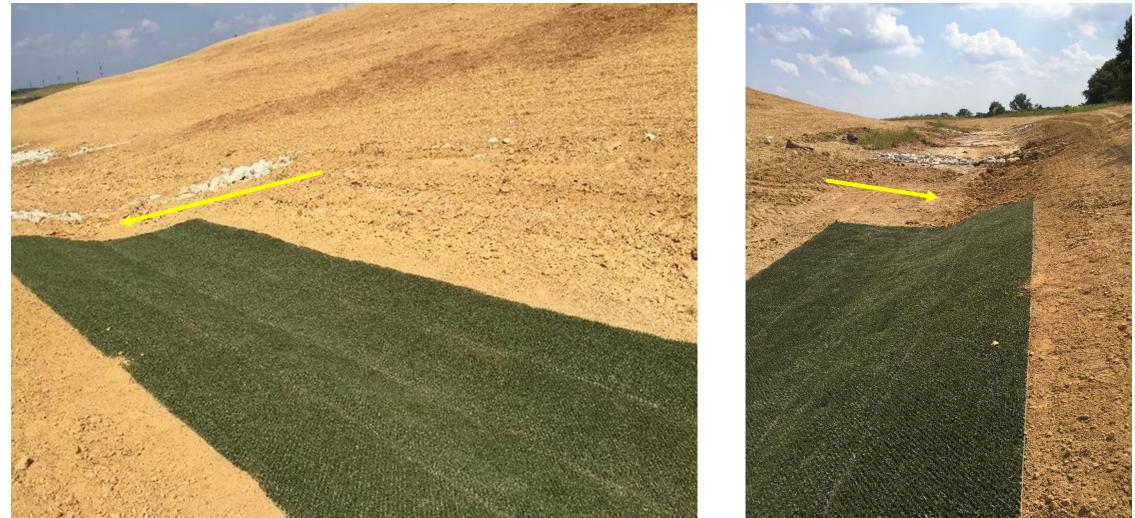
Mats were installed between rock checks using 8 inch sod staples and 6 inch fabric pins on 1.5 ft centers according to published InstaTurf installation guidelines. Note small sections of channel downstream and upstream of mats left unprotected for comparison.

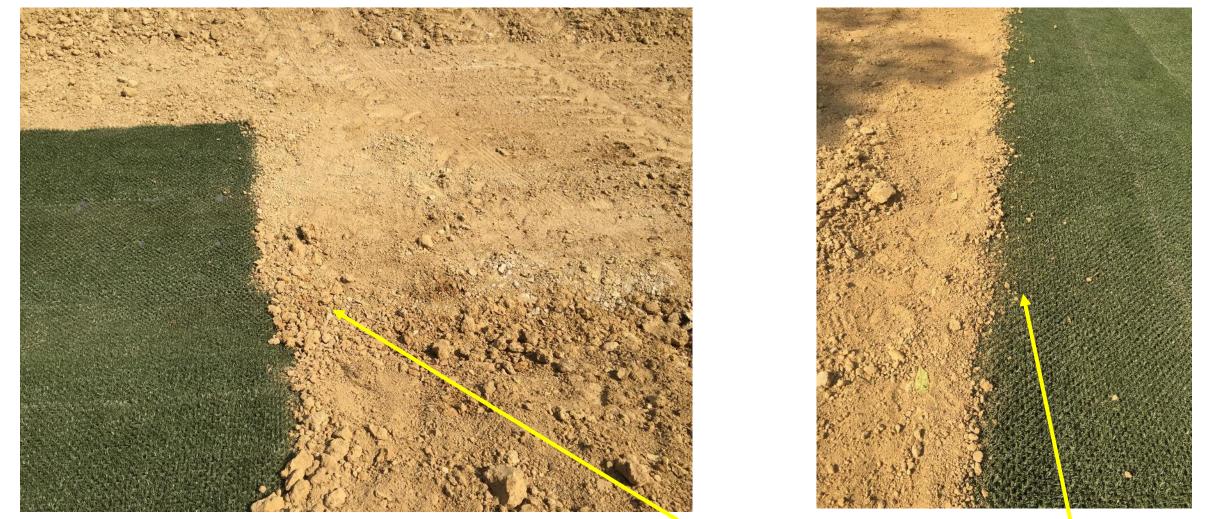
Upslope terminal ends of mats were trenched in approximately 6 inches (left). Mat edges at top of both sideslopes (Right photo) and downstream terminal ends were simply stapled on 9 inch centers with loose soil placed over edges.

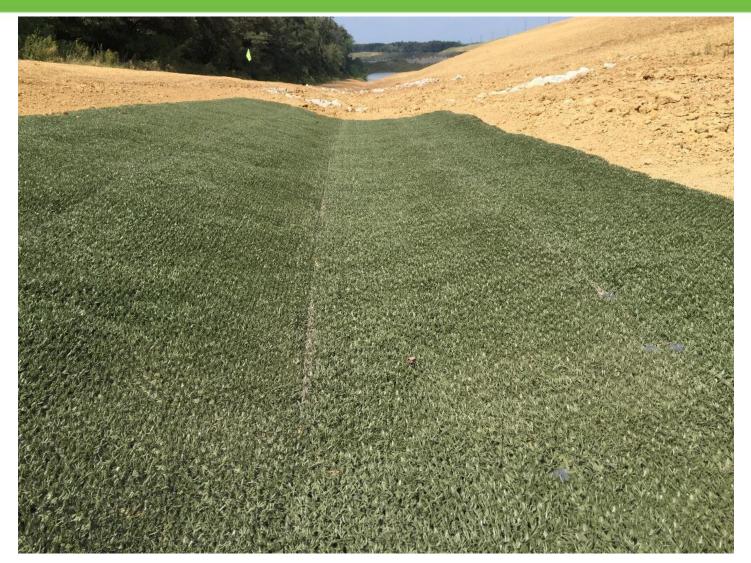
Completed ShearForce10 Installation looking down channel grade

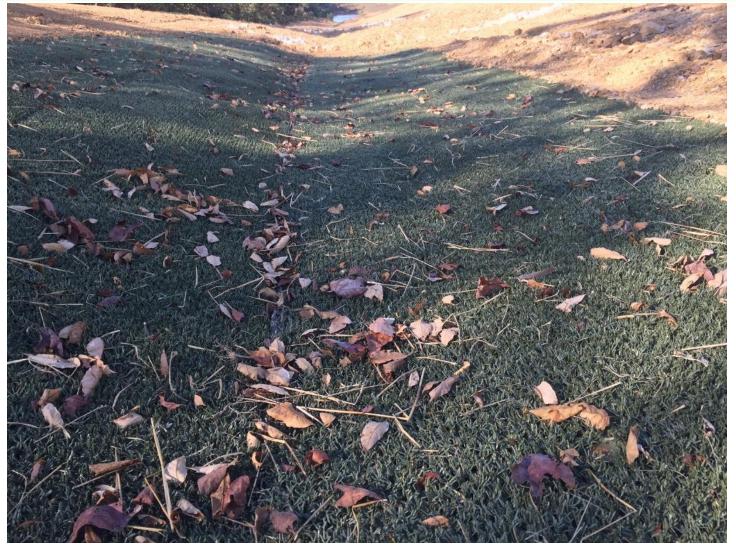
Due to the lack of rainfall in September (.6 inch total), very little germination had occurred by Oct 7

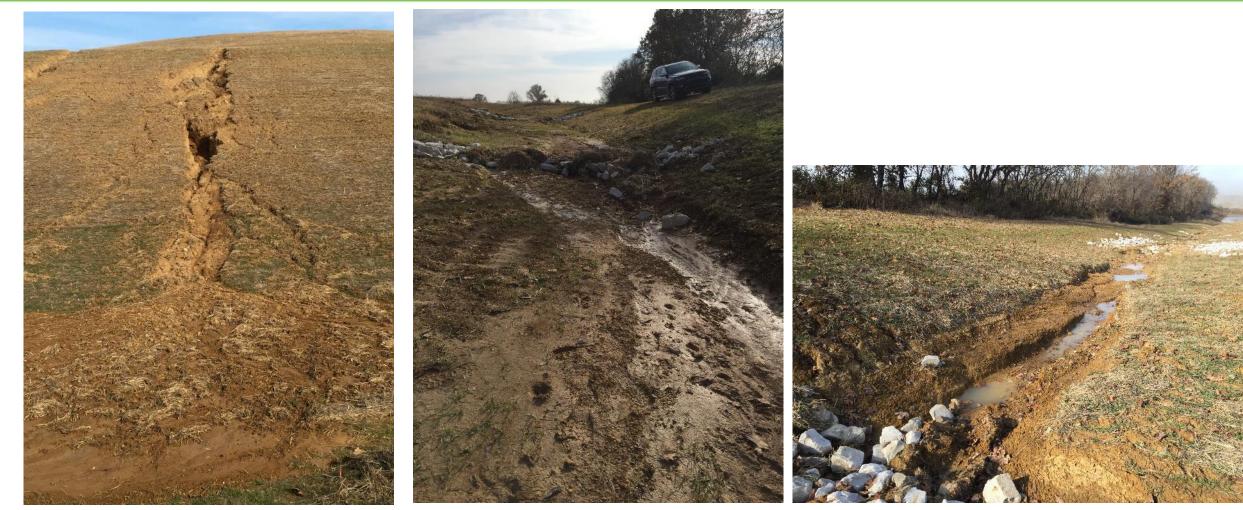
#### Major Erosion Damage of Unprotected Areas Caused by Late October Storm Flows

...Just two weeks later, the rains came, with major storm events on Oct 21 (1.65 in) and Oct 26 (2.2 in) wreaking havoc on straw mulched slopes/channel bottom and riprap check dams as apparent in these photos taken Nov 20. Over 6.5 inches of rain fell in October, what a mess!

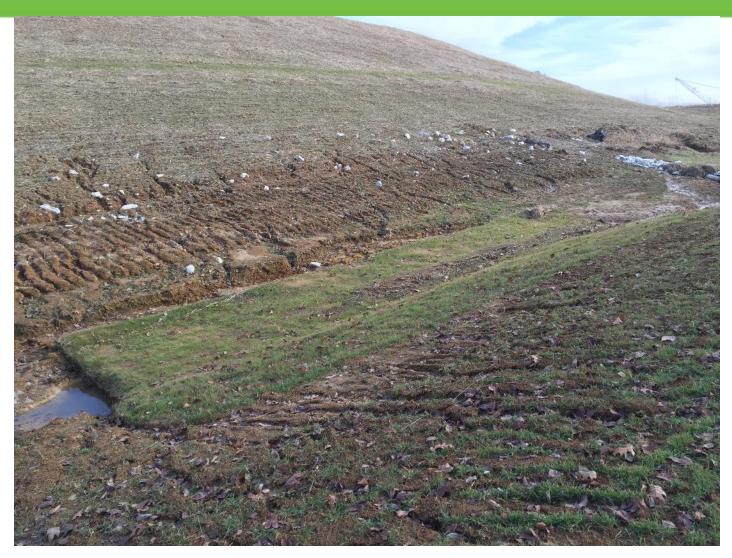
As illustrated by the severe erosion and scour of adjacent unprotected soils , the ShearForce10 performed incredibly well at armoring the channel, while growing and reinforcing natural grass under extreme conditions!

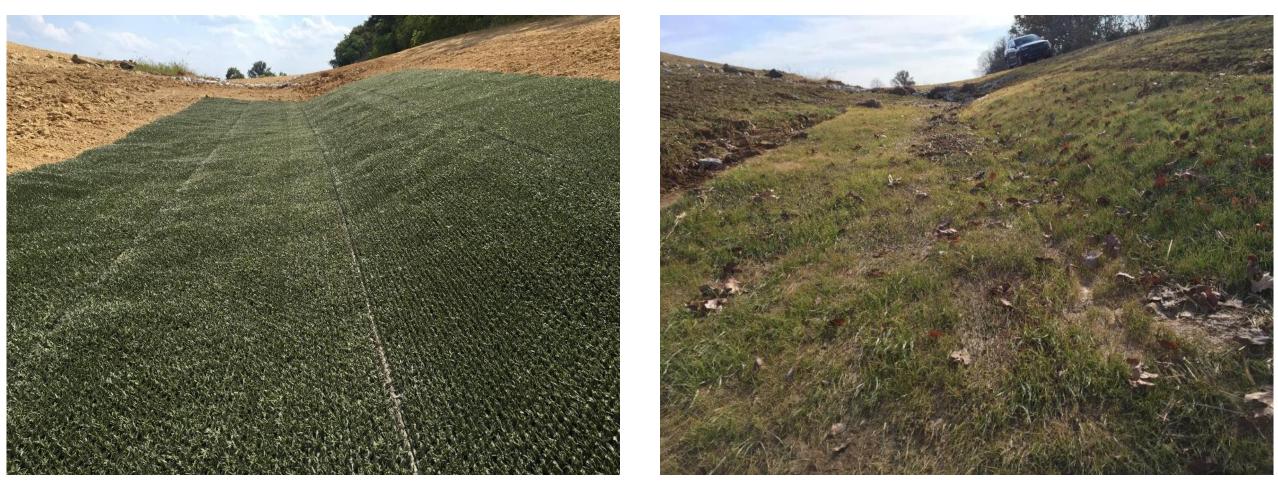
Upslope view of ShearForce10 just after installation on Sep 10 (left) and on Nov 20 (right).

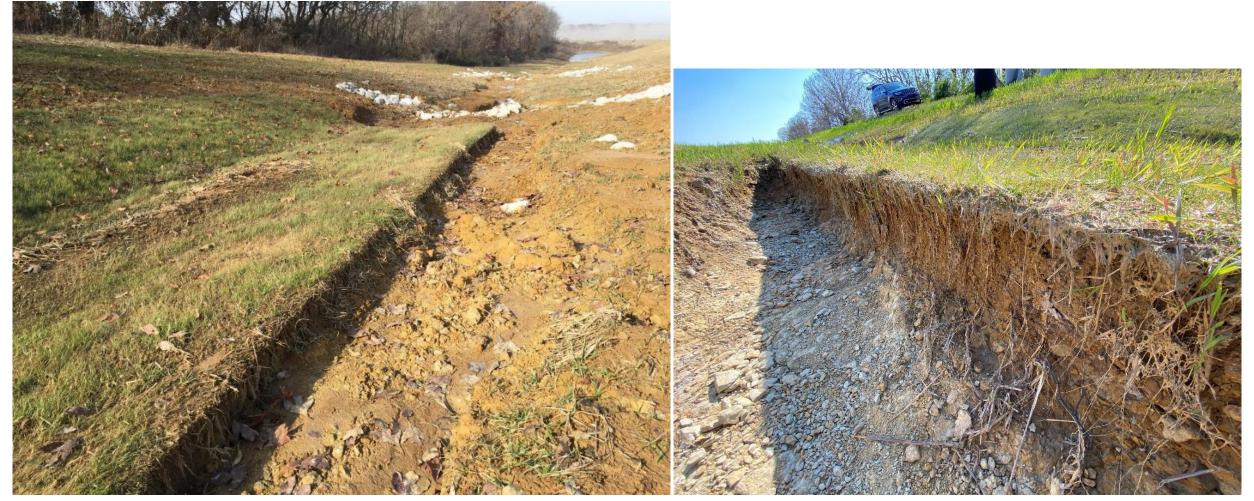
### The Consequences of Underestimating Flow Depth

But wait, there's more. Apparently we should've used more ShearForce10! The right sideslope (looking downstream) where no ShearForce10 was used was badly scoured by over 8 inches. Incredibly, the ShearForce10 prevented erosion of soils and vegetation directly under it. Never seen anything like this before!

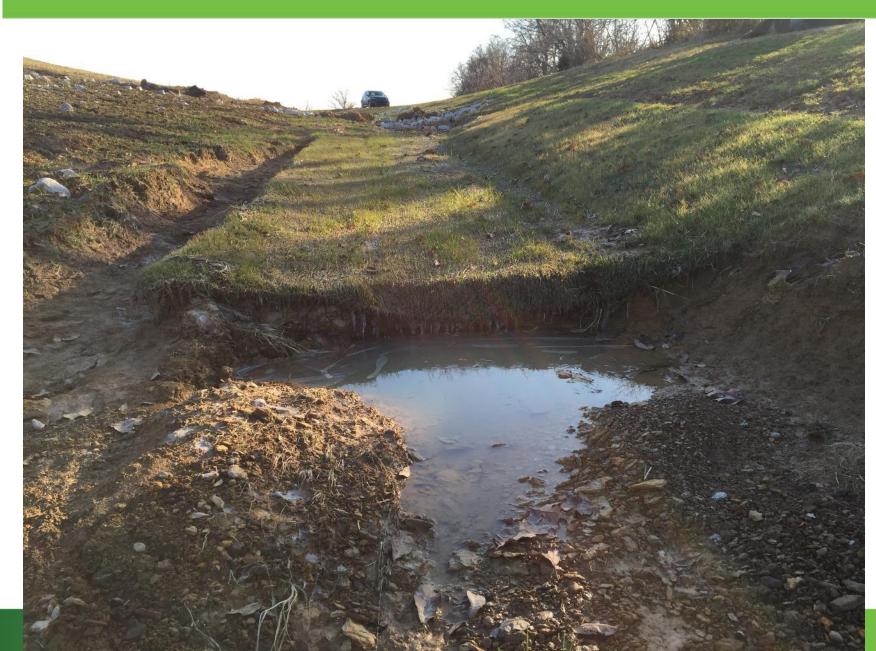
#### Dec 2019 - Scour of Unprotected Downstream "Control" Section

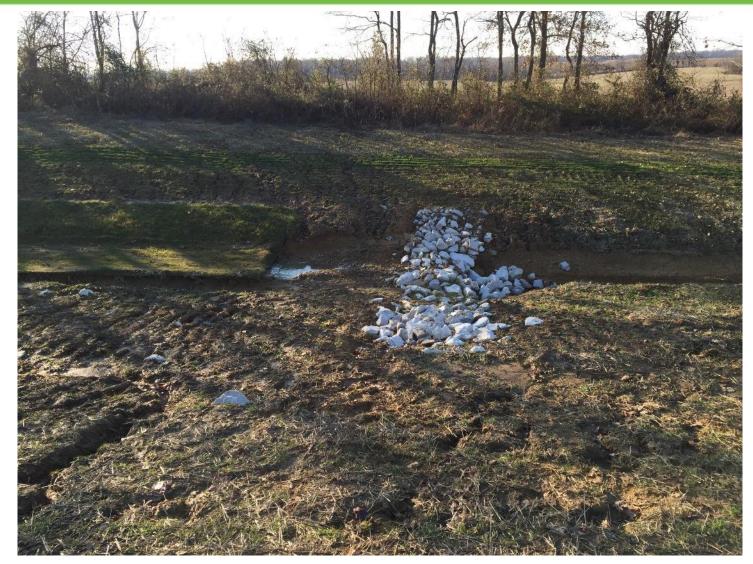
The unprotected area downstream from the ShearForce10 and rock check exhibited severe scour.

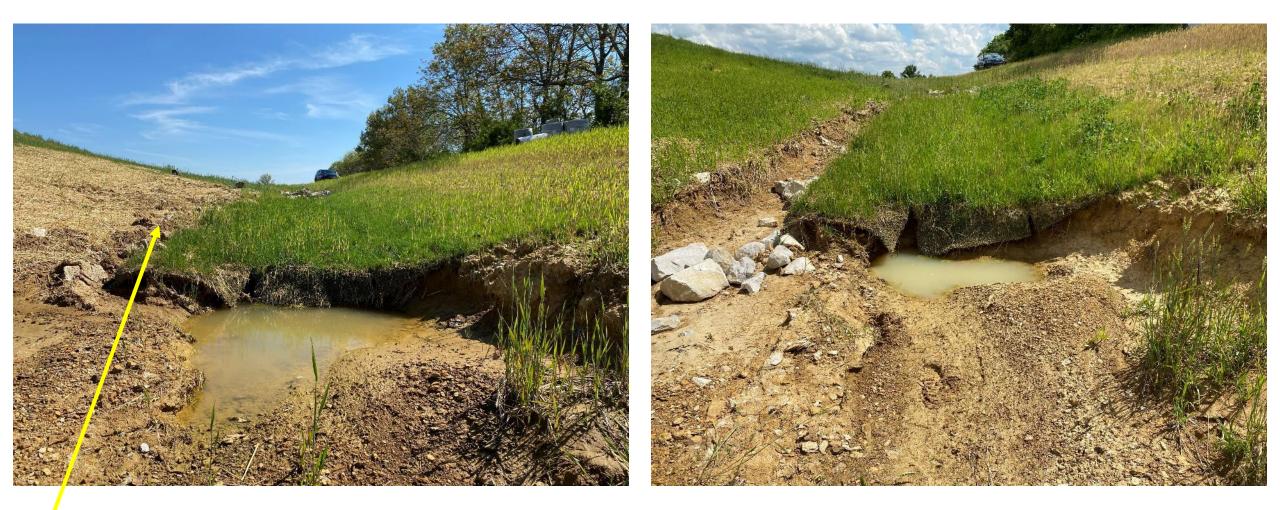
May 1, note in-filled gully left side of test section

May 28, in-filled soil washed out, rock deposited from check dam upstream

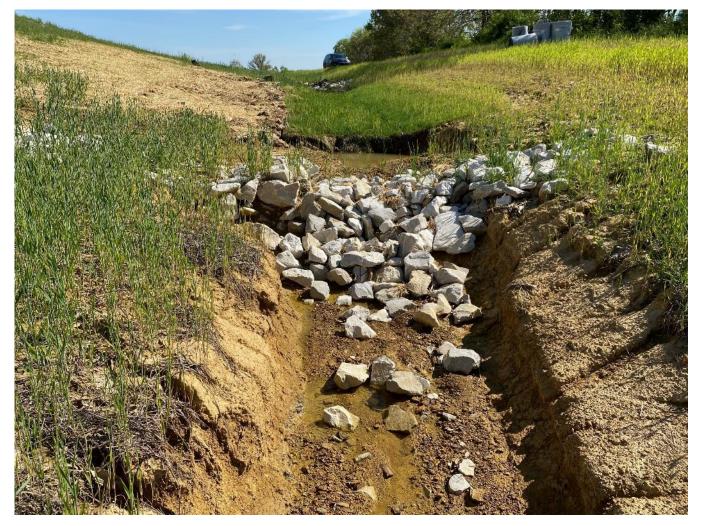
May 1, downstream rock check dam damage

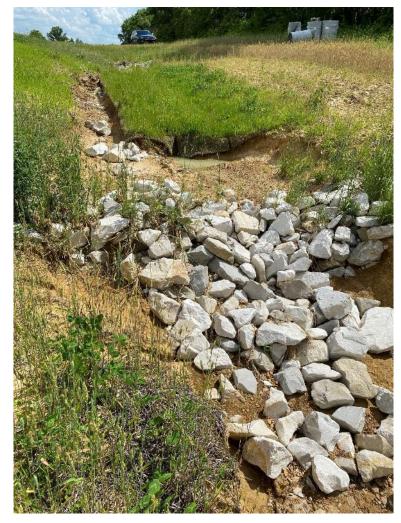
May 28, leveled rock check dam
