# Preserving Hawaiian Coastline with a Low Impact Sediment Barrier

## PERIMETER CONTROL FOR A CUSTOM HOME SUBDIVISION PROJECT - 10/12/2017

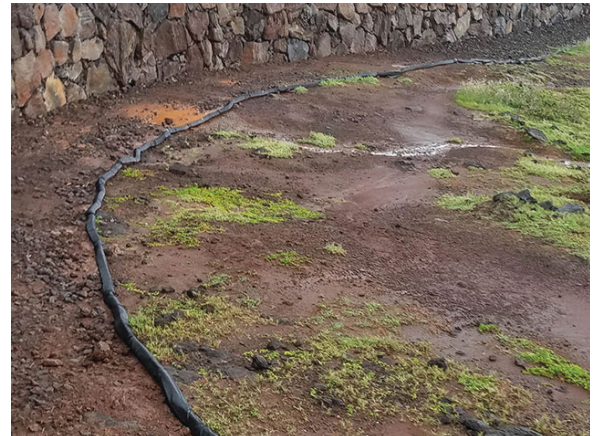
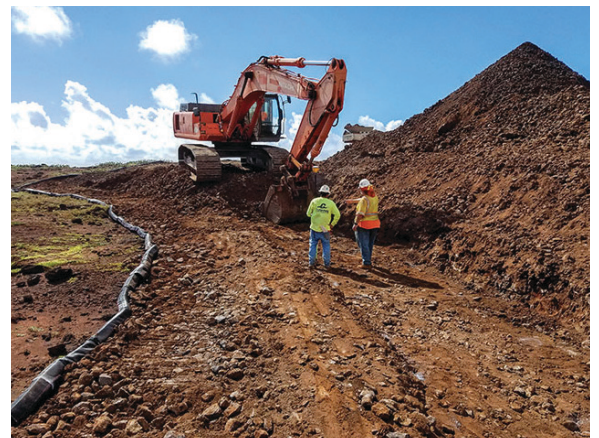
According to his research, DuraWattle was the best alternative to silt fence that could provide a continuous sediment control barrier across multiple surface types. The product also solved the issue of a low impact installation; the recommended hard surface installation of DuraWattle

would keep the basalt rock shoreline intact while keeping sediment trapped on site.

DuraWattle is also designed to be driven over by heavy traffic. Subcontractors would be driving excavators near the perimeter when constructing the grouted rock walls. The product would be able to bounce back and remain effective during heavy rain events even after being driven over by excavators.

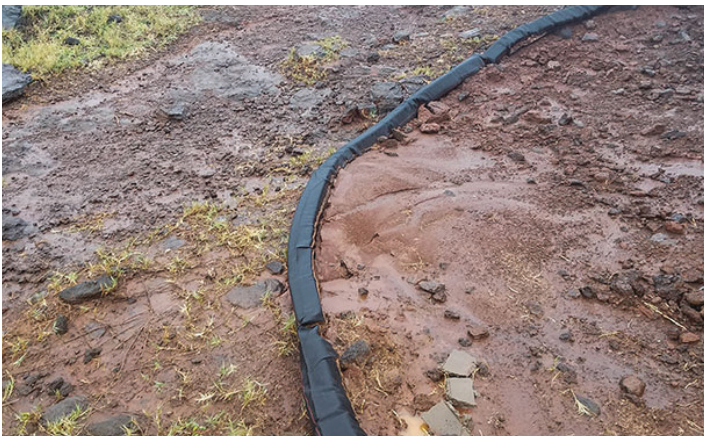
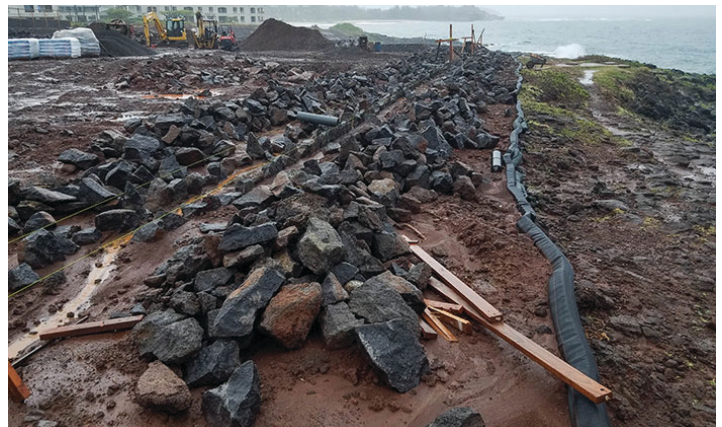
The install team used the provided pins and washers to install the product

on soil and powder-actuated fasteners with lath when installing on the solid basalt rock. Hard surface installation of DuraWattle usually has the product secured to the ground using wood planks or steel strips. However, the basalt rock was too uneven, and Davidson had to secure the fasteners directly into the tail section and "backfill" over the tail section with 3"- 6" gravel.

This project was being constructed during Kauai's rainy season, and large rain events could be expected at any time. Augmenting the DuraWattle with gravel over the tail section was necessary to keep sediment on site. Without the tail section sealed securely to the ground, any heavy concentrated flow would have undermined the DuraWattle at the uneven sections of rock and caused a massive BMP failure, especially given the project's proximity to the ocean.

The gravel helped to dissipate the stormwater flow enough to allow the DuraWattle's high flow filter medium to retain sediment and create sheet flow off site. Davidson's team needed to re-backfill the tail section in a few locations, and remove the built-up silt in other areas. However, Davidson was very impressed with the performance of the BMP combination.
