GEOWEB®

CANAL SHORELINE STABILIZATION

EROSION PROTECTION FOR STORM WATER CANAL EMBANKMENTS

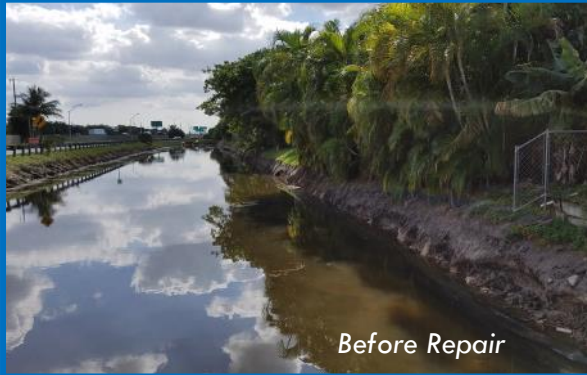
Before Repair

**Eroded Canals Caused by Years of Storm
Related Water Fluctuations Required Repair.**

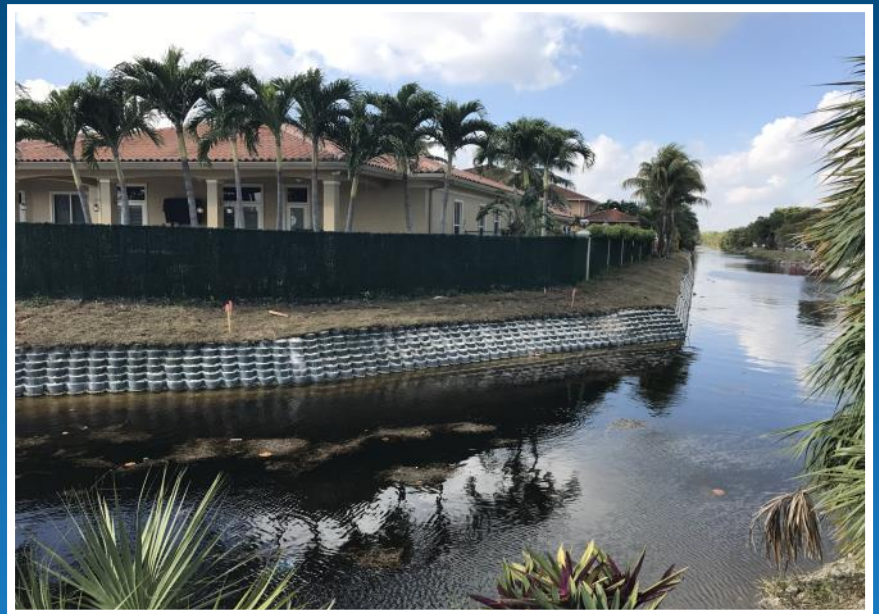
Structurally-Sound, Natural Embankments

The GEOWEB system's flexible nature allowed for conformance to the many curves and turns in the channels. The GEOWEB wall sections below the water line were filled with rock. Soil and vegetation were installed above the water line to allow for natural aesthetics. Green wall fascia panels were chosen for aesthetic appeal and blending with the vegetation. **Over 12,000 Face Sq Ft. of the GEOWEB channel protection system was installed.**
