HydroTurf®

Channel Bank Protection

HydroTurf® Z

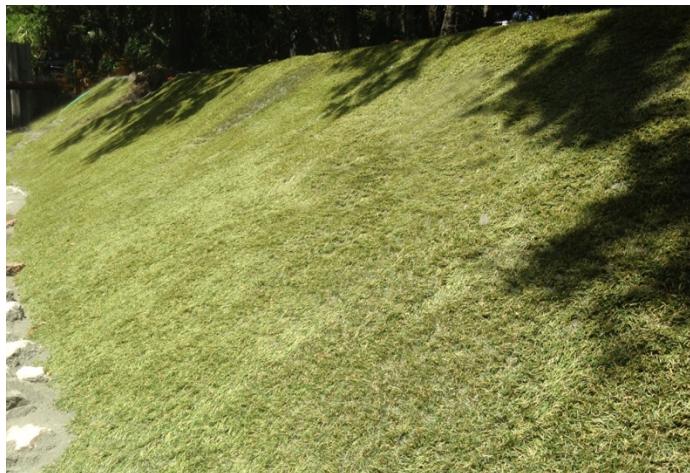
HydroTurf® was easily installed on steep 1.5:1 slopes.

One project in particular included channel improvements in portions of the ditch located between Palomino and Aurora Roads. In order to mitigate overtopping, the existing channel was cleaned out and widened to increase flow capacity. The project proved to be challenging with two 90° bends and 1.5:1 side slopes. With homes being adjacent to the channel, the county wanted something that would not interfere with the natural aesthetics of the subdivision and that would reduce the potential of future repair and maintenance in order to minimize disruption to the surrounding community.

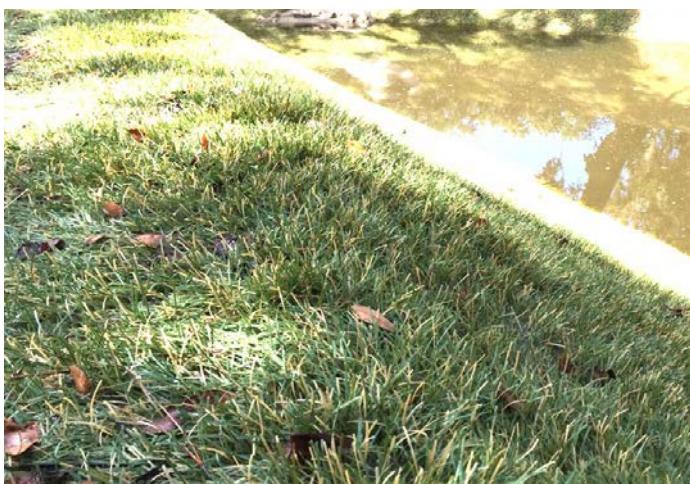
The HydroTurf® color chosen was a blend of both green and tan to match the surrounding environment.

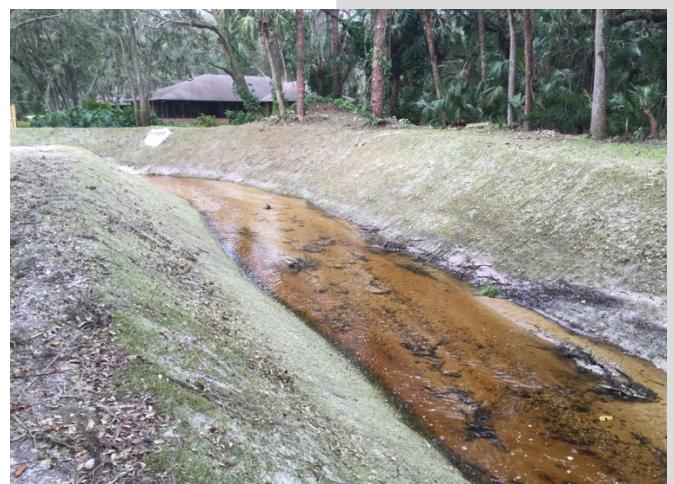
The HydroTurf® channel in great condition just after Hurricane Matthew passes.

Just two months after final completion, the storm season raged with Hurricane Matthew, a Category 3 event. Even with heavy rain (peaking around a 50-year storm for the six-hour period and a 25-year storm for the 24-hour period) and 70 mph winds in the Melbourne area, the HydroTurf channel performed just as designed with no damage and no follow-up maintenance required. A year later, on September 10th, 2017, Hurricane Irma put HydroTurf to yet another test. Although the storm had reduced from a Category 5 to a Category 1, wind gusts still maxed out at 94 mph. The HydroTurf system stayed in place with no damage.

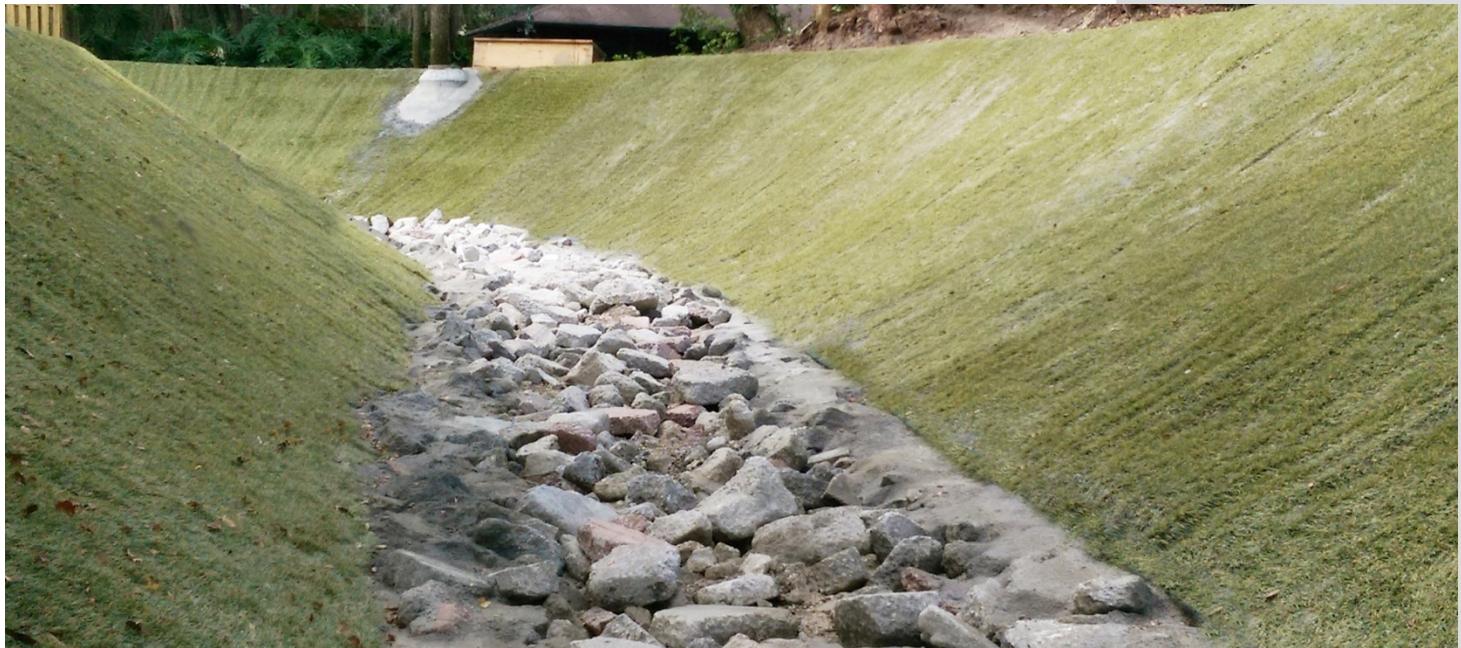
Because of the high groundwater table, the design included HydroTurf® on the slopes and riprap for the channel bed.

To protect the new steepened slopes from the hydraulic forces and propensity for erosion, the county chose the HydroTurf® advanced revetment system. In addition to the natural vegetated look, HydroTurf provides a 50-year minimum design life that will require very little, if any, maintenance. It will also withstand high velocities which could surge in this area during major storm events.

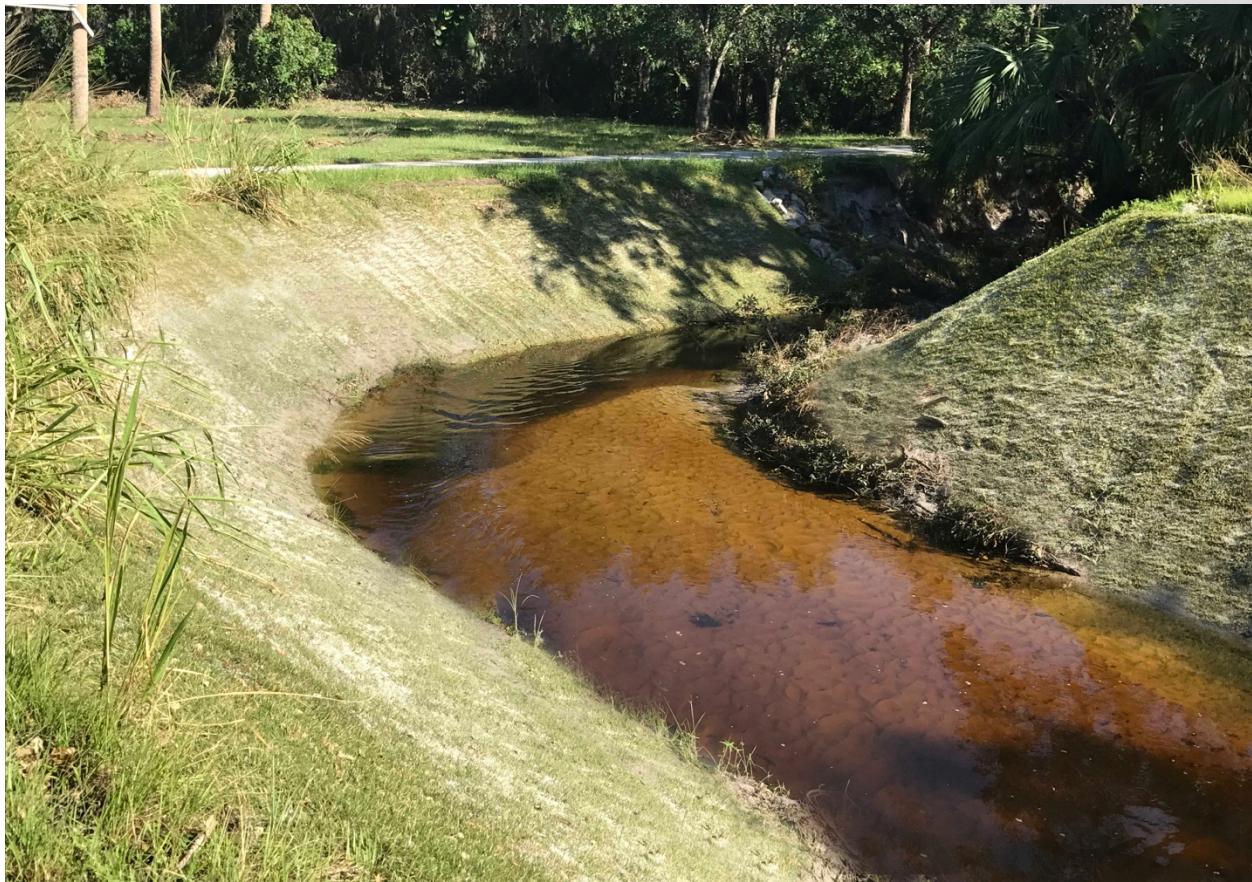
HydroTurf® just days after Hurricane Irma hit the state of Florida in September 2017.
