# Project Profile: Horasan Kurtozu Sarıkamış Highway

## 'Impossible' Roadside Rehabilitation a Success in Turkey

**PROJECT NAME**  
Horasan Kurtozu —  
Sarıkamış highway project

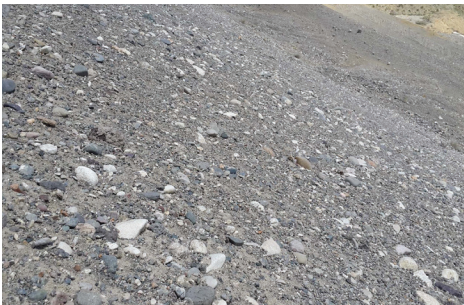
*The existing soil had minimal organic levels as well as low pH.*

During highway construction near Horasan, Turkey, the nation's Director of Highways was faced with erosion issues on a steep slope, where previous abatement treatments had failed. Specifically, the director was looking for a permanent, environmentally-friendly solution that was also cost-efficient. After considering an environmentally unfriendly stone wall, the head of the construction team reached out to Profile Products for expert assistance. After a complete soil analysis, Profile discovered that the soil had low levels of organic structure as well as low pH levels.

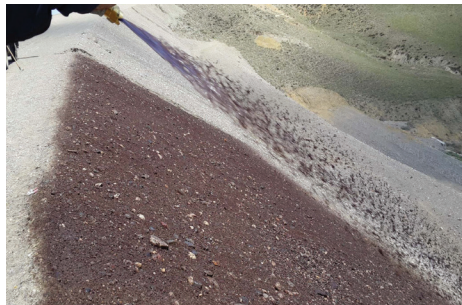
*ProGanics™ was applied to amend the existing soil.*

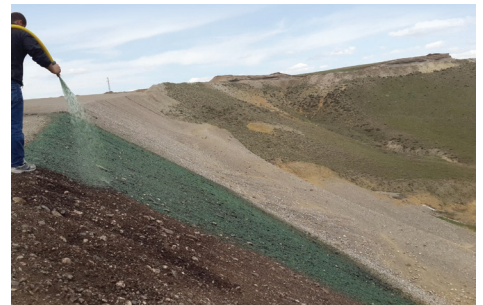
*Flexterra® HP-FGM™ was then applied to prevent erosion and sediment runoff.*

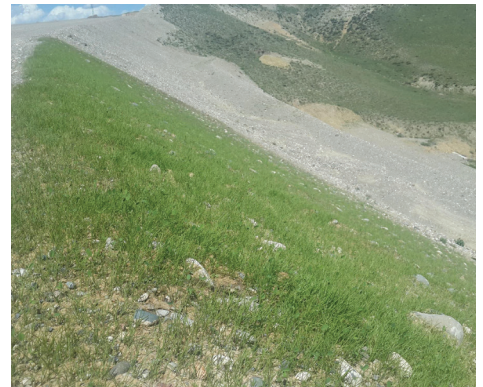
*Vegetation established in just 20 days.*

Before the demo, Profile was told that the contractors had deemed the area to be beyond rehabilitation. A mere 20 days later, however, the results convinced them otherwise. Vegetation had been established and the slope stabilized.
