### INTRODUCTION

Machado Lake is located in the Ken Malloy Harbor Regional Park near Harbor City, CA. The park is approximately 290 acres and contains the 45-acre Machado Lake. The primary goal of the project was to improve the water quality in Machado Lake, while enhancing the surrounding natural habitat and the recreational features of the park. The project and this presentation describe some of the in-lake improvements, such as dredging approximately 239,000 cubic yards of lake sediment and capping the lake bottom with AquaBlok, as well as use of a sediment trap system to address storm water inputs and rehabilitating the dam structure at the south end of the lake. The vegetation, habitat, and park improvements include invasive plant removal and replanting of native species, such as fishing piers, fencing, and walkways.

This poster will provide an overview of the project from the perspective of the materials used and application.

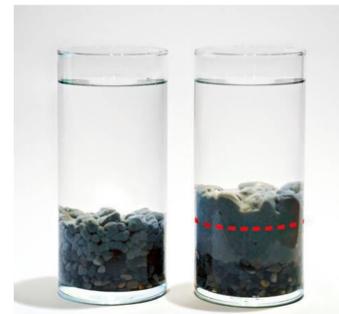
**AquaBlok** 1 min post hydration → time → **AquaBlok** 24 hr post hydration

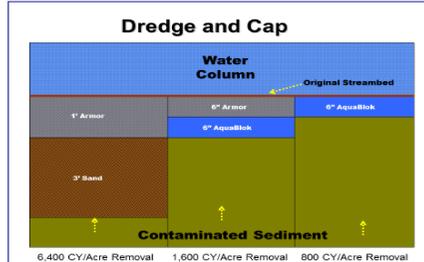
The above graphic illustrates the concept and shows the reduction in removal volume that can be achieved assuming different assumptions regarding cap type and cap thickness.

The Dredge & Cap approach is intended to focus dredging activity only on the highest levels of contaminant concentrations within a site. Removal should not be driven by achieving a low target residual concentration level because remaining contaminants in the sediment can be effectively sequestered or isolated with either a low-permeability cap (AquaBlok) or a permeable in-situ amendment layer (AquaGate).

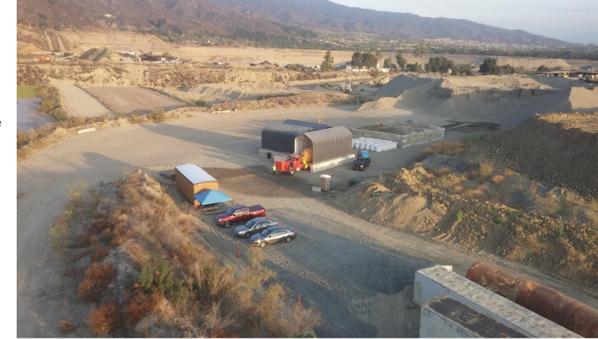
Since the primary weight and volume of AquaBlok is stone, the manufacturing facility for AquaBlok materials in Southern California is located at a stone quarry south of Corona, CA (see photo to the right). Production is carried out in conventional ready mix concrete mixers. Material is off-loaded into bins and material is transferred to bulk dump trucks for transport to the Machado Lake site, which is an approximate one hour drive from the production facility. Early in the project, it was expected that AquaBlok would be produced on-site at Machado, but it was determined to be more cost effective to deliver the finished material rather than stone to the project site.

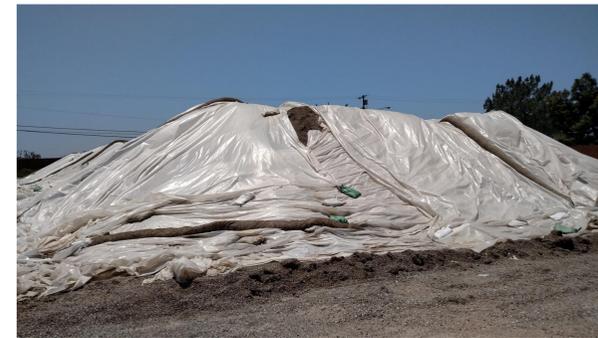
To the right is a photo of the AquaBlok stockpiled at the project site. After off-loading from the trucks, stacking conveyors were used to create large piles that could be covered with a high density plastic cover to protect the material from rain. In spite of these measures, it was estimated that from 1%-3% handling losses would take place due to material handling and water damage to the material.

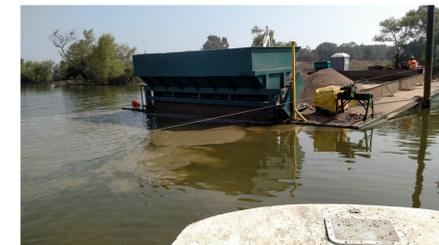
Installation was performed with a hopper/barge system that was able to place a thin-uniform layer in a 20-foot wide 'lane' across the lake bottom. The material to keep the placement barge productive was provided by a separate supply barge, which was loaded with AquaBlok from the lake shore. The photo to the top left shows the placement barge and hopper during application of AquaBlok. The photo to the bottom left shows the material stock on the placement barge and the mini-excavator that was used to load the hopper.
