LittaTrap[™]

Toyota LittaTrap™ Pilot Results

The LittaTrap[™] is an innovative catch basin insert that has been designed to capture litter, plastics and other debris such as contaminated sediment. The device is easily installed inside of a stormwater catch basin. The product has been laboratory tested and shown to capture 99% of trash debris (>5mm) and improve the capture of total suspended solids by the catch basin by 40%. This report presents the findings of the pilot across seven sites over the 100 days of capture.

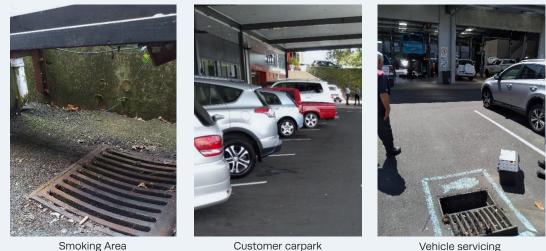
The stormwater drains at each dealership were specifically selected based on the presence of certain nearby amenities which are known hotspots for litter generation. These include smoking areas, parking and service zones as shown in Figure 3.

Figure 3 Catchment characteristics that correlate with high litter loading.

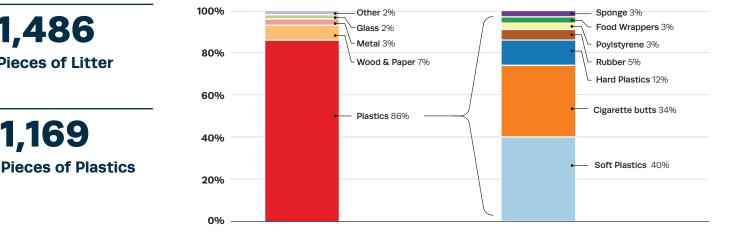
The composition of the total litter and the percentage of plastics captured by the devices is shown in Figure 5. Cigarette butts are a type of single use plastic but are given their own category due to the amount found. The innovative design of the LittaTrap™ allows for adaptable use. This means that the device can be designed for specific land uses and the specific pollutant generated. Part of this design is making replacement parts readily available in the very rare case of damage to the unit. Minor damage was reported on two units and replacement baskets were fitted as part of the pilot.

Figure 5 Litter Composition with detailed breakdown of plastic found in this pilot.

The results show that 673 pieces of litter were captured during the first collection followed by 759 pieces of litter captured the second collection. This gives a total of 1,432 pieces of litter over 100 days of which 1,169 pieces were made of plastics. These pieces of litter and plastics would have otherwise entered the stormwater system where they would likely flow out to the sea, impacting the receiving environment.

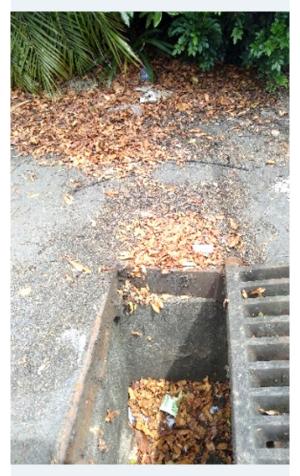
Figure 7 Litter within leaves around a catch pit prior to the quick and easy installation of a LittaTrap $^{\text{TM}}$.

By installing four devices at each dealership and targeting the hotspots (Figure 7) could equate to 118,000 pieces of litter being caught each year based on these results. One hundred thousand of those items would be expected to be plastic.
