**PROJECT STAKEHOLDERS**

**CHALLENGES**

**APPLICATION**

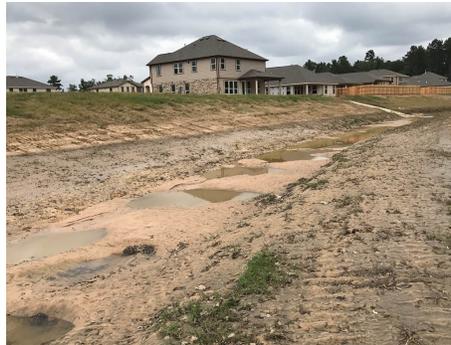
*A failed embankment emptied into a nearby creek*

Construction of a residential development site in Conroe, Texas increased the amount of water being diverted to nearby Cayden Creek. Due to the increased water flow, a spring storm caused a levy on the creek to break and overflow into detention ponds. Profile® and the contractor began working with the developer, the Municipal Utility District, the Texas Commission on Environmental Quality and the U.S. Army Corps of Engineers to create a solution. Rather than working against nature, developers chose to let water continue to flow into the ponds and created a parallel drainage system. The developer needed to further reinforce the overflow zone against high shear and velocity forces, plus establish sustainable vegetation throughout the drainage

system. They determined the best solution would be Profile's GreenArmor System™, a vegetated and environmentally superior means of protecting high-discharge waterways and steep slopes. Soil tests showed poor quality of the existing soil, so Stuckey's LLC first applied ProGanics® Biotic Soil Media™ (BSM™), an Engineered Soil Media™ (ESM™). ProGanics restores soils by providing the organic and biological components needed to establish sustainable vegetation. Stuckey's LLC installed the GreenArmor System on the floor of the channel by laying Futerra® 7010 Turf Reinforcement Mats (TRMs) and infilling them with Flexterra® High Performance-Flexible Growth Medium® (HP-FGM®). For the remaining area above the high-water line that would not be subjected to concentrated flow, ProMatrix™ Engineered Fiber Matrix™ (EFM™) was hydraulically applied to provide erosion protection. Within two months, the site was fully vegetated. Over the spring and summer, the site saw more than 94 inches (2,388 mm) of rain — including a 60-inch (1,524 mm) deluge from Hurricane Harvey. Through it all, the site held up and the contractor was able to translate this success into more projects.

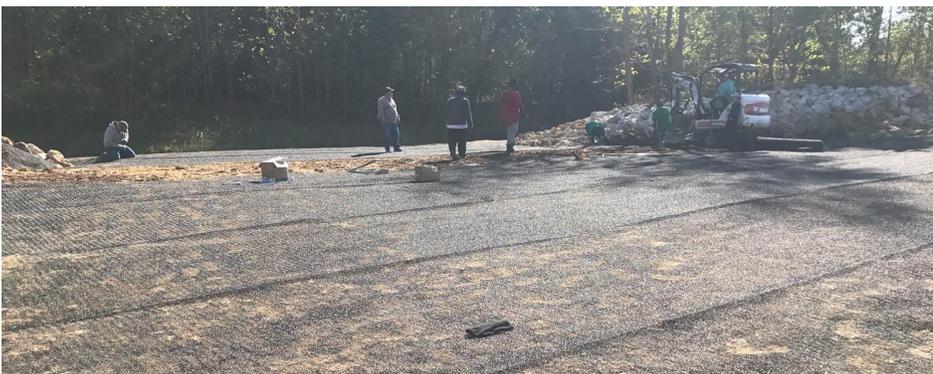
*Installation of TRM reinforces root systems to withstand more severe flow*

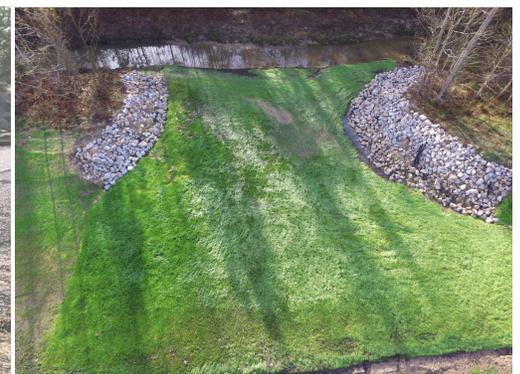
- The combination of ProGanics soil building properties and the reinforced turf solution provided excellent vegetation and a strong root system
- This solution stood up to the extreme rains and winds of Hurricane Harvey

*Vegetation on the site two months later*
