PROJECT PROFILE

Project Name: Colorado I-225 Slope Stability Project
Installation Date: May 2016
Product Type: Western Excelsior Xtreme Armor System™ (XAS) utilizing PP5-Xtreme with Percussion Driven Anchors (PDAs)
Project Location: Greater Denver Area, Colorado

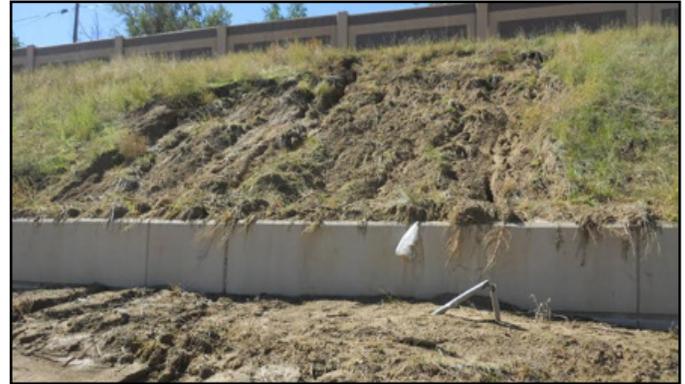
Rapid snow melt and spring rains resulted in shallow slope failures (top). The XAS system installed with percussion driven anchors over prepped and seeded soil, provided surficial slope stability and resulted in a stable vegetated slope (center, bottom).

Denver Colorado is a sprawling, busy metropolis at the foot of the Rocky Mountains. In the Northeast quadrant of the city, I-225 connects I-70 and I-25, allowing travel from the south end of the city to the airport and along a busy industrial corridor. Traffic interruptions are a significant problem for the Colorado Department of Transportation (CDOT) as lane closure means long delays for drivers. A retaining wall had been constructed along one portion of the highway, with a steepened slope leading to a neighborhood above and behind the wall. Saturated from winter snowfall, the slope was particularly vulnerable to spring rains. Once fully saturated, the weight and moisture content of the slope created instability which allowed large masses of soil to slide off the slope and into the shoulder of the road. This led to repeated soil clean-up and replacement, lane closures, and unacceptable direct and indirect costs. After conversations with Western Excelsior, Xtreme Armor System was the solution of choice for CDOT.
