GEOWEB®

DIKE EMBANKMENT STABILIZATION

LNG ENERGY PROVIDER
Northeast US

3D Soil Confinement System Repairs Eroded Dikes Protecting LNG Storage Tanks

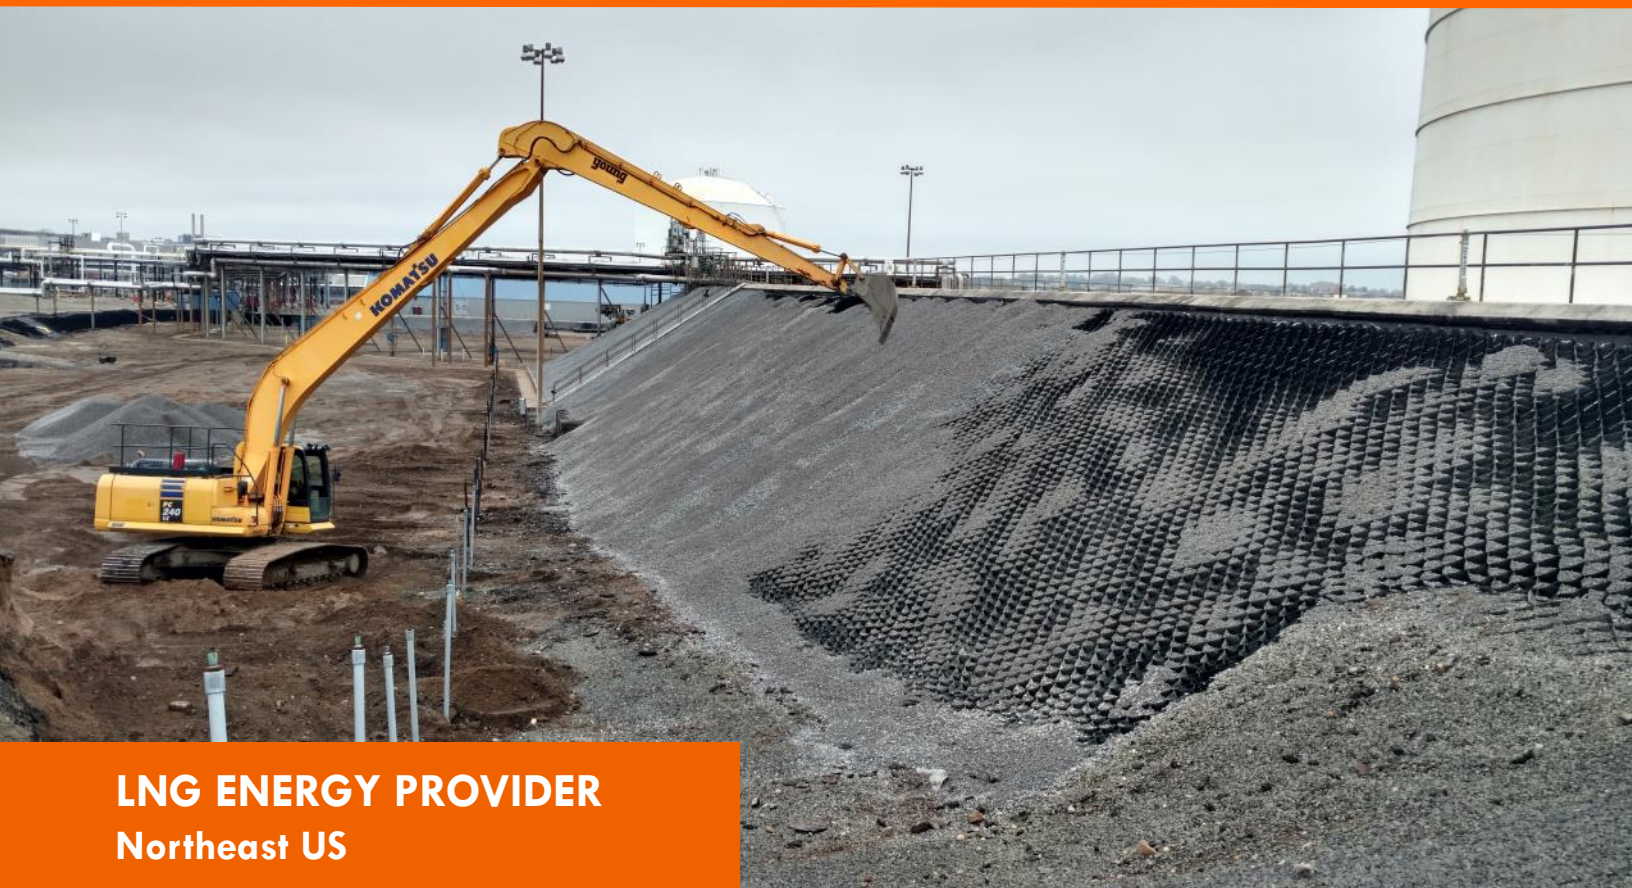
Degraded Original Asphalt Cover

To repair 100,000 sf (9,300 sm) of eroding primary and secondary dikes around a Liquid Natural Gas (LNG) storage tank. The original asphalt cover had deteriorated along the face of the dike largely due to expansion and contraction issues. A slope adjacent to an access roadway showed significant degradation caused by pavement cracks in the road that allowed water to penetrate the soil below the asphalt and create large holes in the slope.
