Parkway Slope

PROJECT PROFILE

MINNEAPOLIS, MINNESOTA

A Holistic Approach to Erosion Control and Vegetative Strategies

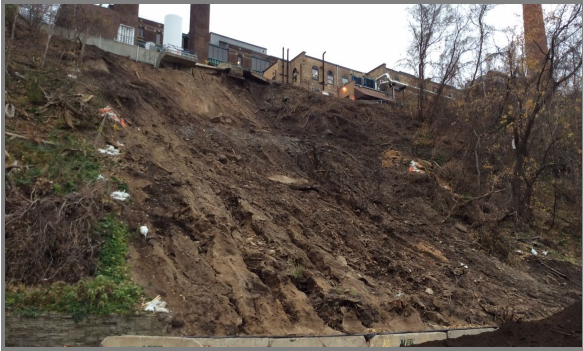
Slope prior to application, June 2014

After topsoil was used to help fill-in the site's new slope, a soil test was performed. Results from the test showed a lack of organic matter in the topsoil. The lack of organic matter made it impossible for the soil to provide the required nutrients to the plant and sustain vegetation. The soil test identified Profile's ProGanics® Biotic Soil Media™ as the prescribed solution. ProGanics not only raised the organic level, it also provided other beneficial constituents to the soil such as biochar, seaweed extract, humic acid and endomycorrhizae.

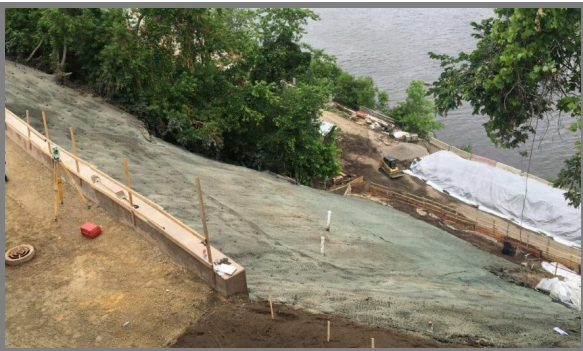
Installation, July 2016

To increase the slope's stability, Futerra 7020 Turf Reinforcement Mat was used to stabilize the soil to provide a stable platform for the plant while it develops its own natural root zone. Flexterra®, Profile's High-Performance Flexible Growth Medium™ was also used to protect the seed and slope from erosion. Together, this created Profile's GreenArmor® System, a combination of superior turf reinforcement and the ideal growth medium for plant establishment.

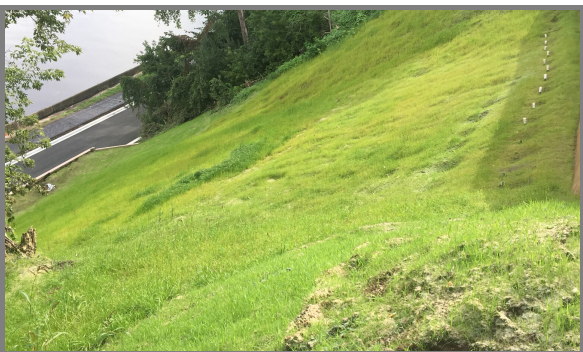
Full vegetation established, August 2016

The decisions made by engineers and contractors to stabilize and reestablish vegetation on the new slope paid off. ProGanics provided the rich nutrient organic matter needed for the seed to become fully establish in less than 2 months. Profile's GreenArmor System protected the site from erosion and helped strengthen the root zone of the vegetation.

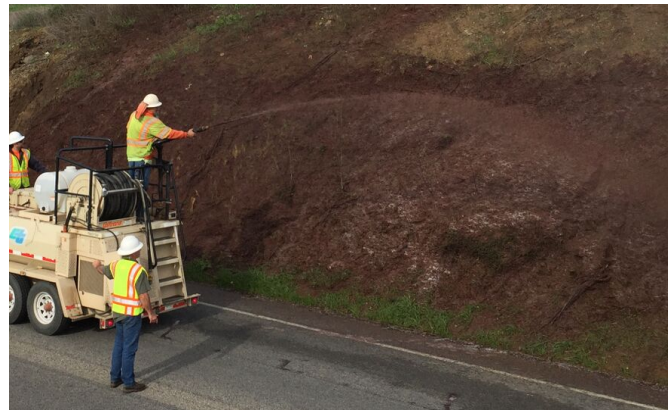
Increase Organic Matter & Boost Soil Fertility

- Accelerates the development of depleted soils/substrates with low organic matter, low nutrient levels and limited biological activity
- An ideal time and money-saving alternative to topsoil and compost
- Excellent for challenging sites with difficult or limited access, and on steep slopes where topsoil placement is impractical or for when soils are too wet or frozen to dig, transport and spread

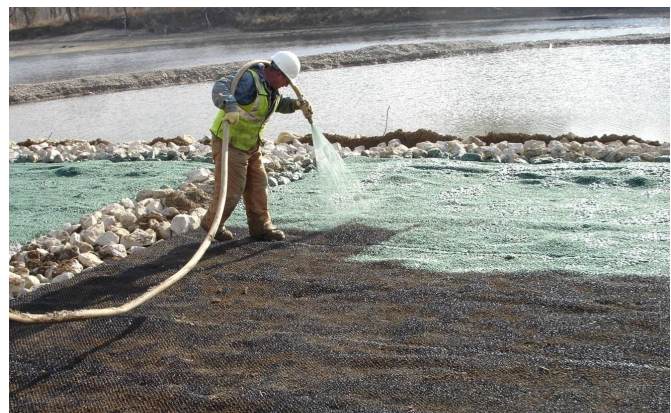
A Revolutionary Green Alternative to Hard Armor

- Futerra® TRM or Futerra® R45 HP-TRM hydraulically infilled with Flexterra® HP-FGM™ delivers unprecedented design safety against elevated levels of hydraulic lift and shear forces
- A more aesthetically pleasing and environmentally superior means of protecting high-discharge waterways and steep slopes
- Installation cost is 30-50% less than hard armor
