Peabody Coal Overwinter Streambank
Stabilization
ShearForce10 Hybrid-Turf Instant Armor Mat

Peabody Coal Streambank Project Details

- **Project Name: Peabody Coal Constructed Streambanks Stabilization**
- **Product: InstaTurf™ ShearForce10™ Hybrid-Turf Instant Armor Mat**
- **Application: Overwinter Protection and Vegetation Establishment on Constructed Streambanks**

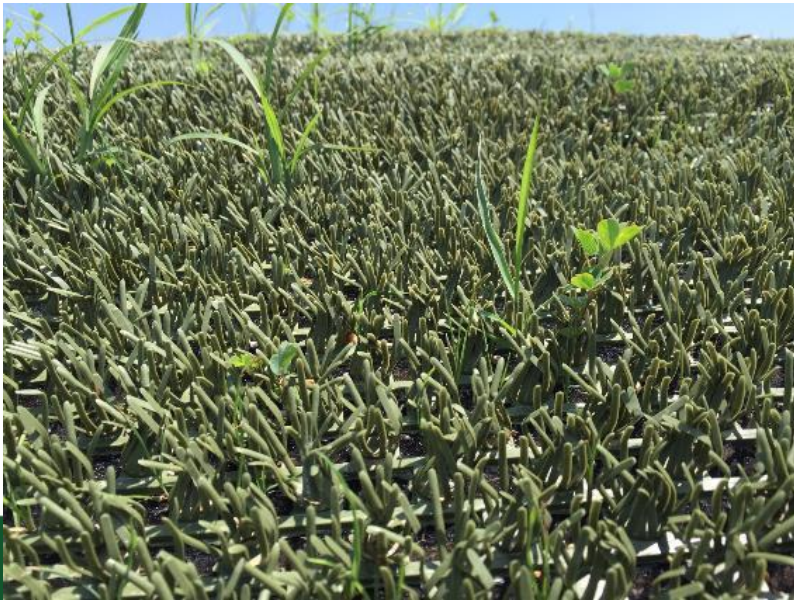
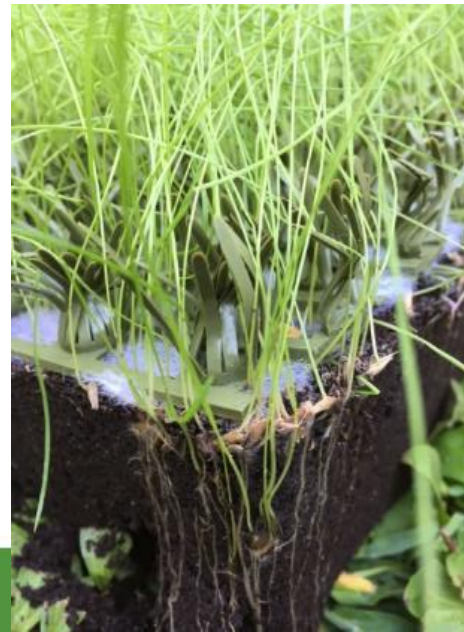
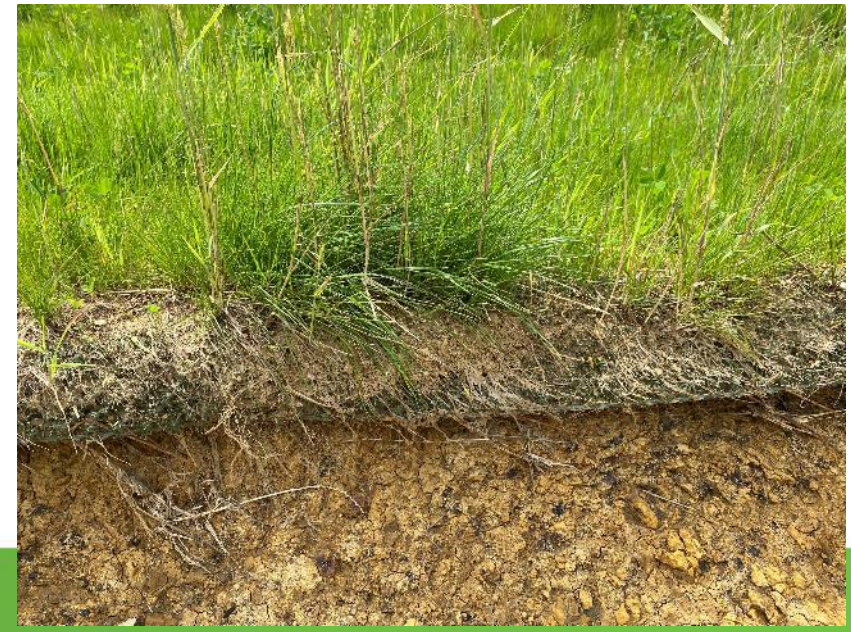
Hybrid-Turf Instant Armor Mat

- 1 inch thick monolithic UV stabilized PE simulated turf structure
- Engineered lightweight PET geotextile fabric backing
- **Forms a virtually non-erodible boundary on the soil surface against high flow-induced shear stresses, while facilitating the establishment and reinforcement of natural vegetation**
- 3ft/6ft wide x 45ft rolls
- Installed over seeded soil surface with 8+ inch wire staples or fabric pins
- Easy to Maintain, Mowable Surface

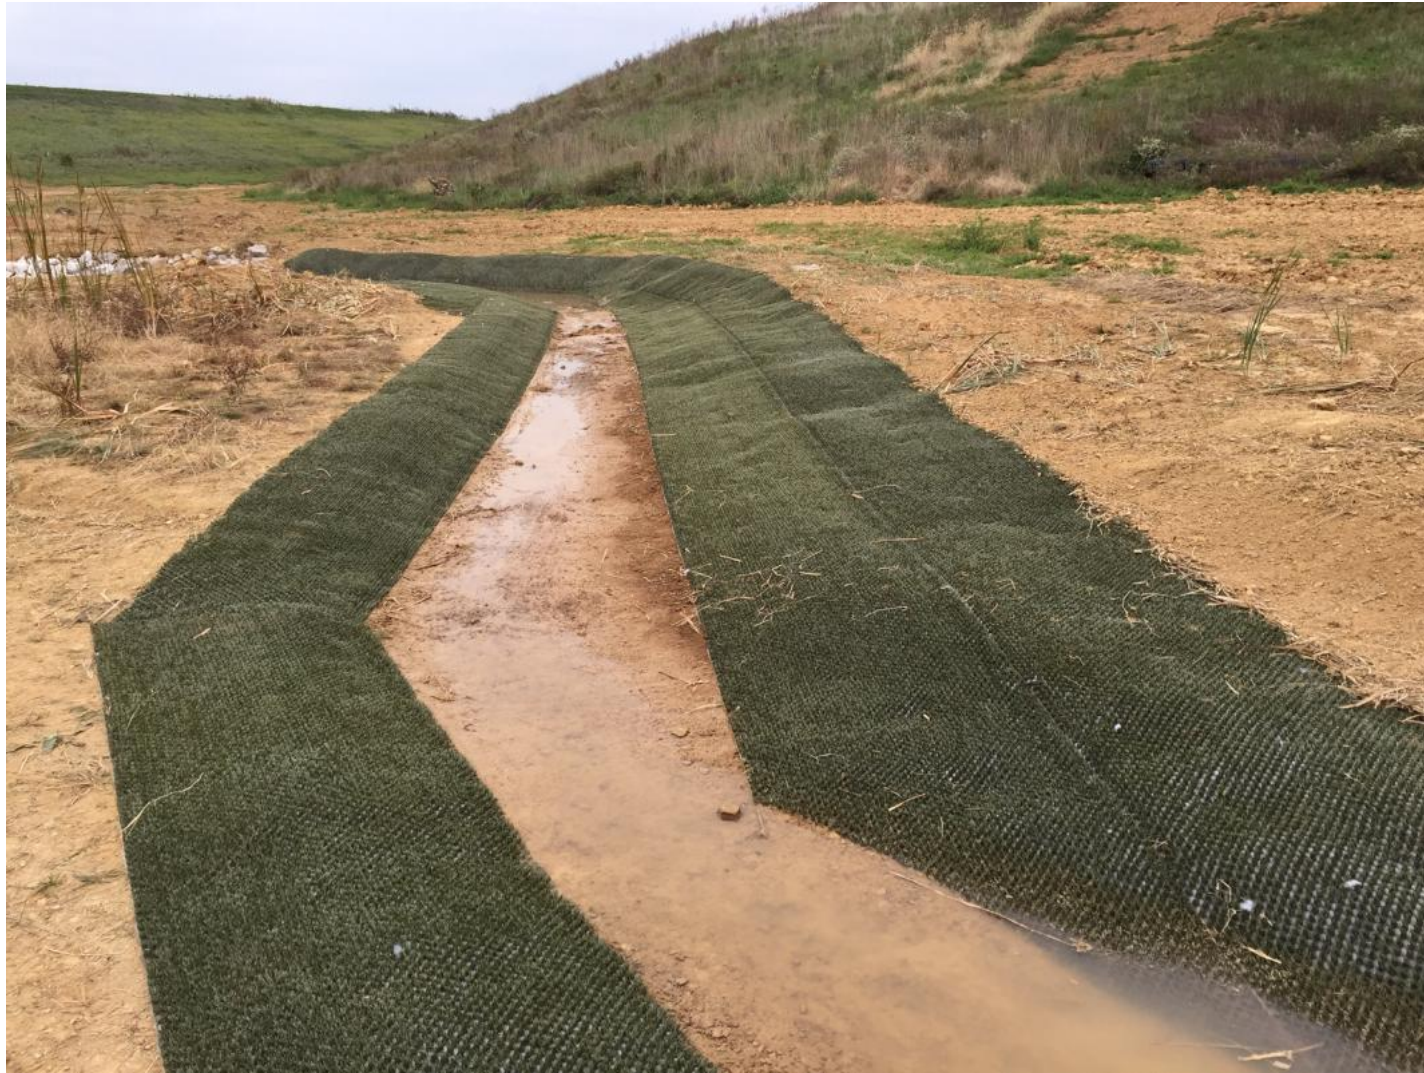
InstaTurf ShearForce10 Instant Armor Mat Installed October 25, 2018 on seeded streambank

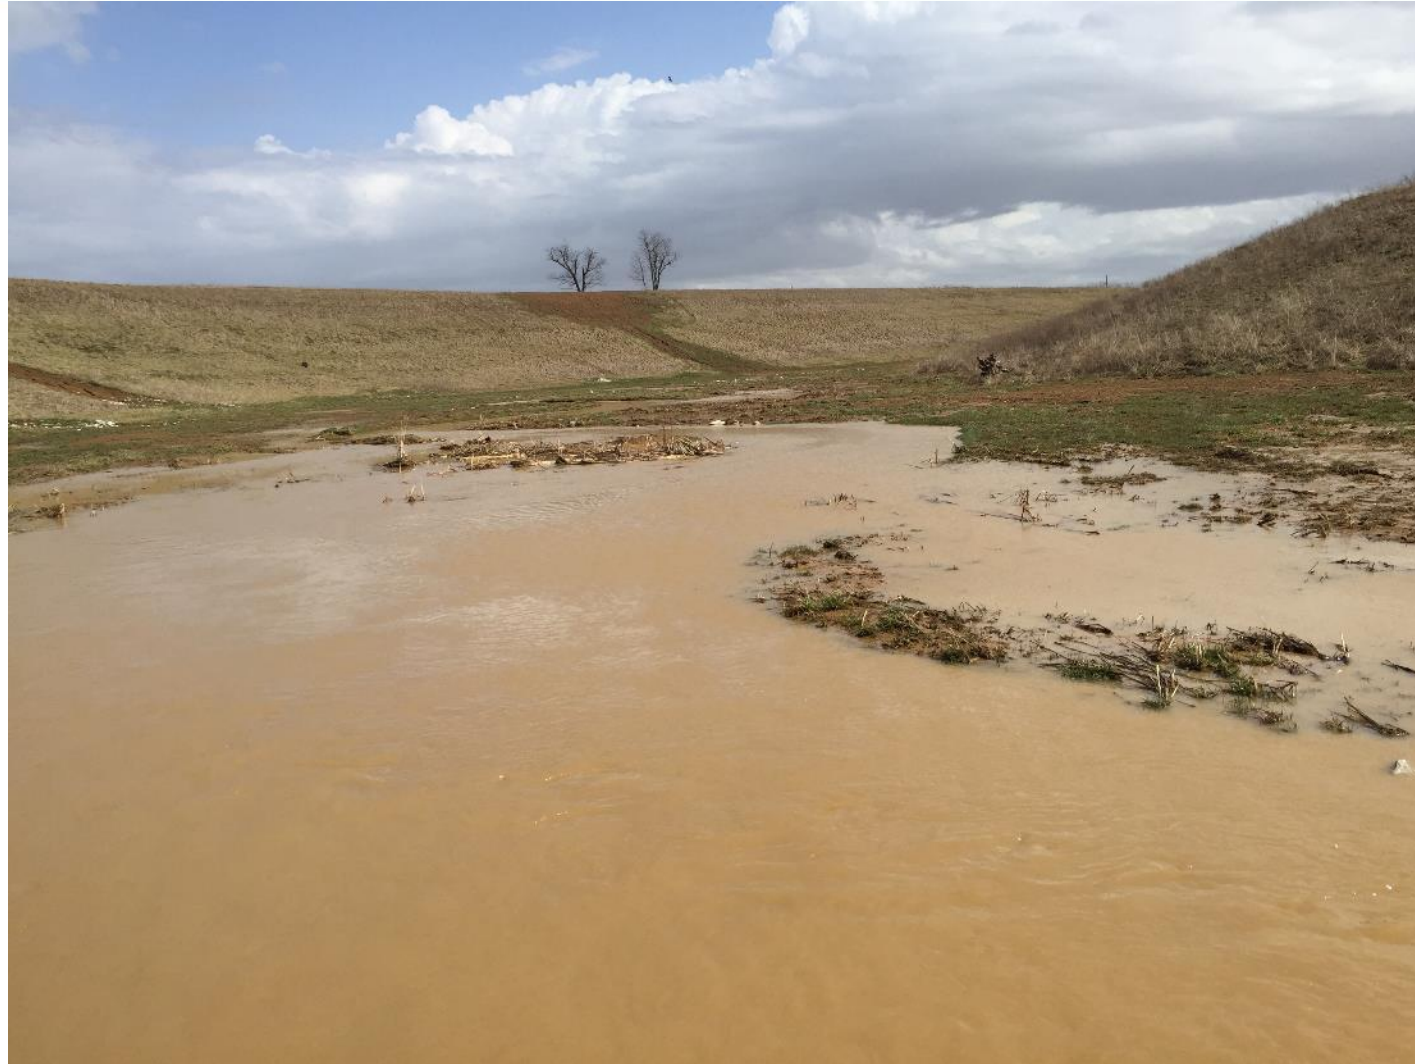
Unusually heavy rains throughout the fall, winter and spring months flooded the stream channel on numerous occasions

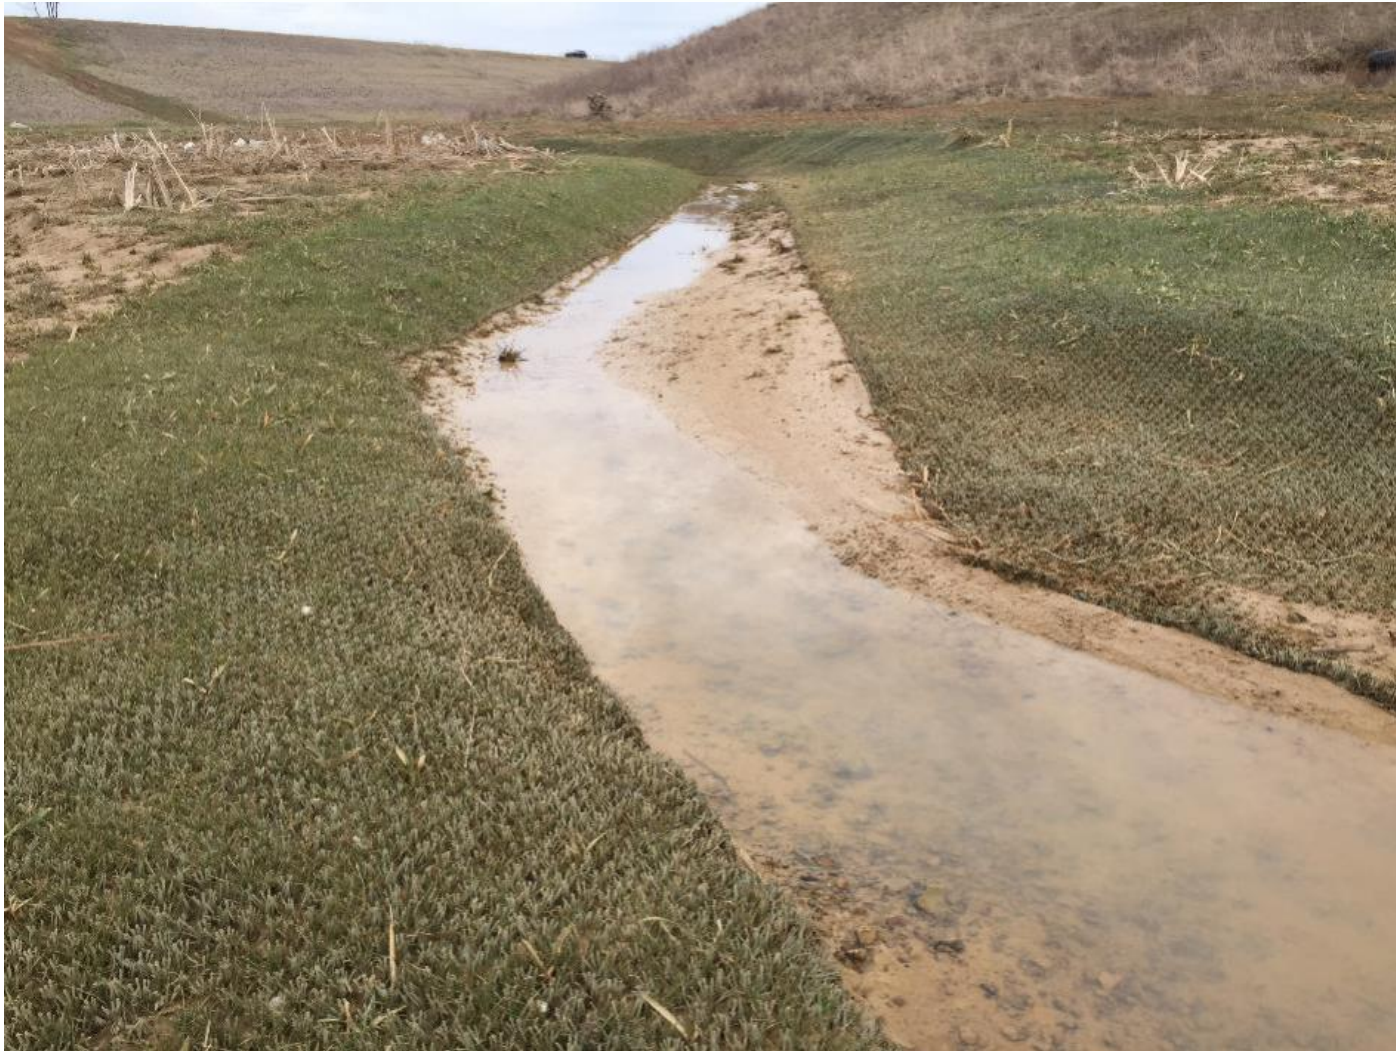
The ShearForce10 did an excellent job of protecting the streambanks through winter. Note the grasses emerging thru mats in early March.

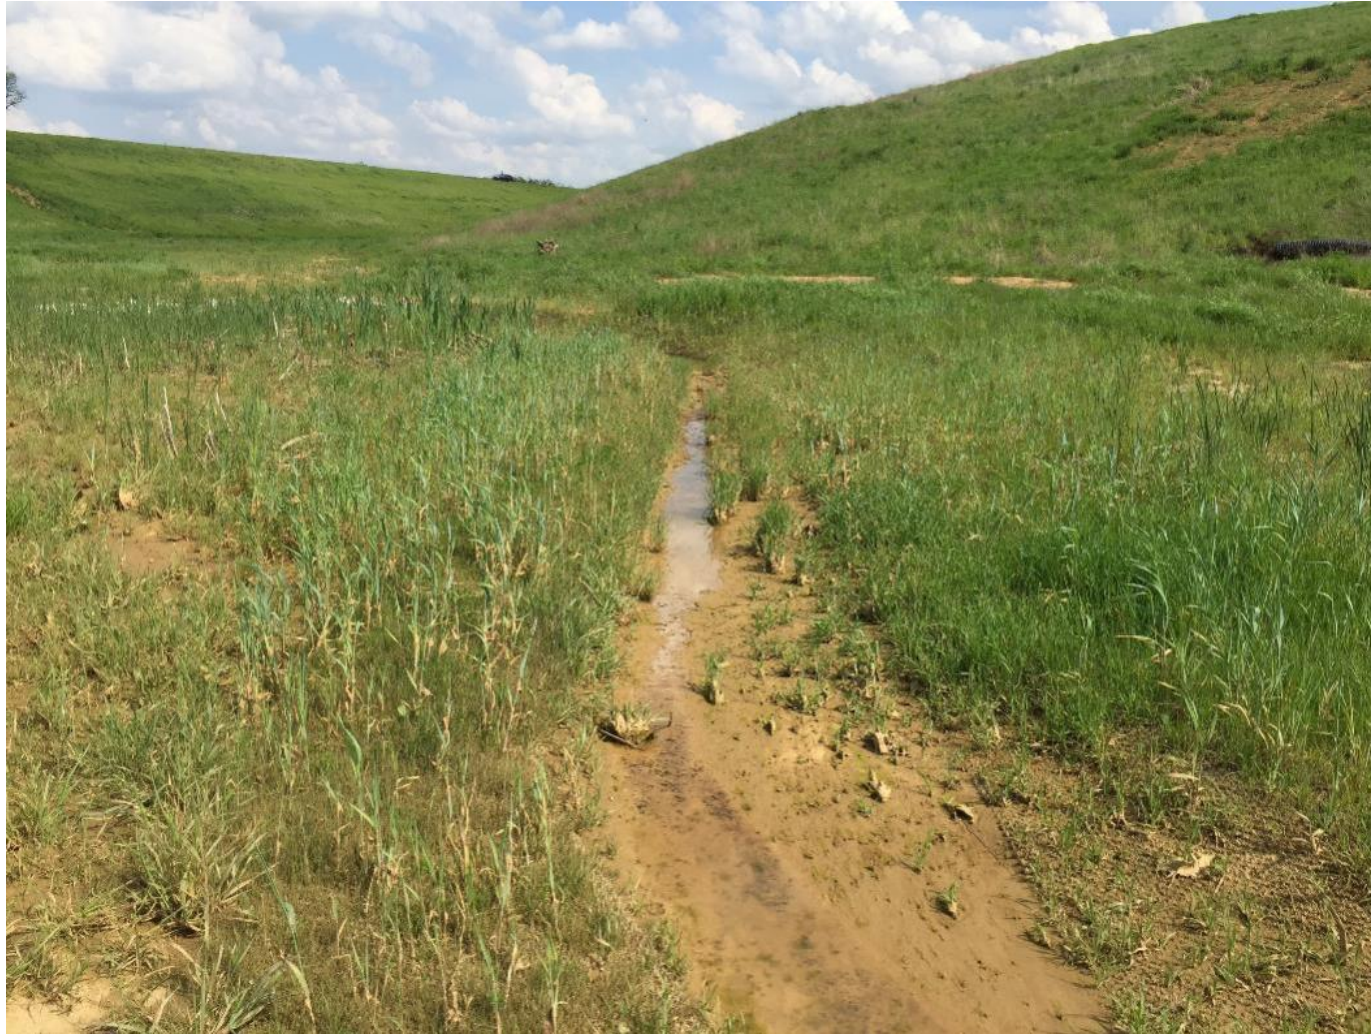
ShearForce10 effectively armored the streambanks through all flood events, sustaining a good stand of vegetation by April 30 and June 30

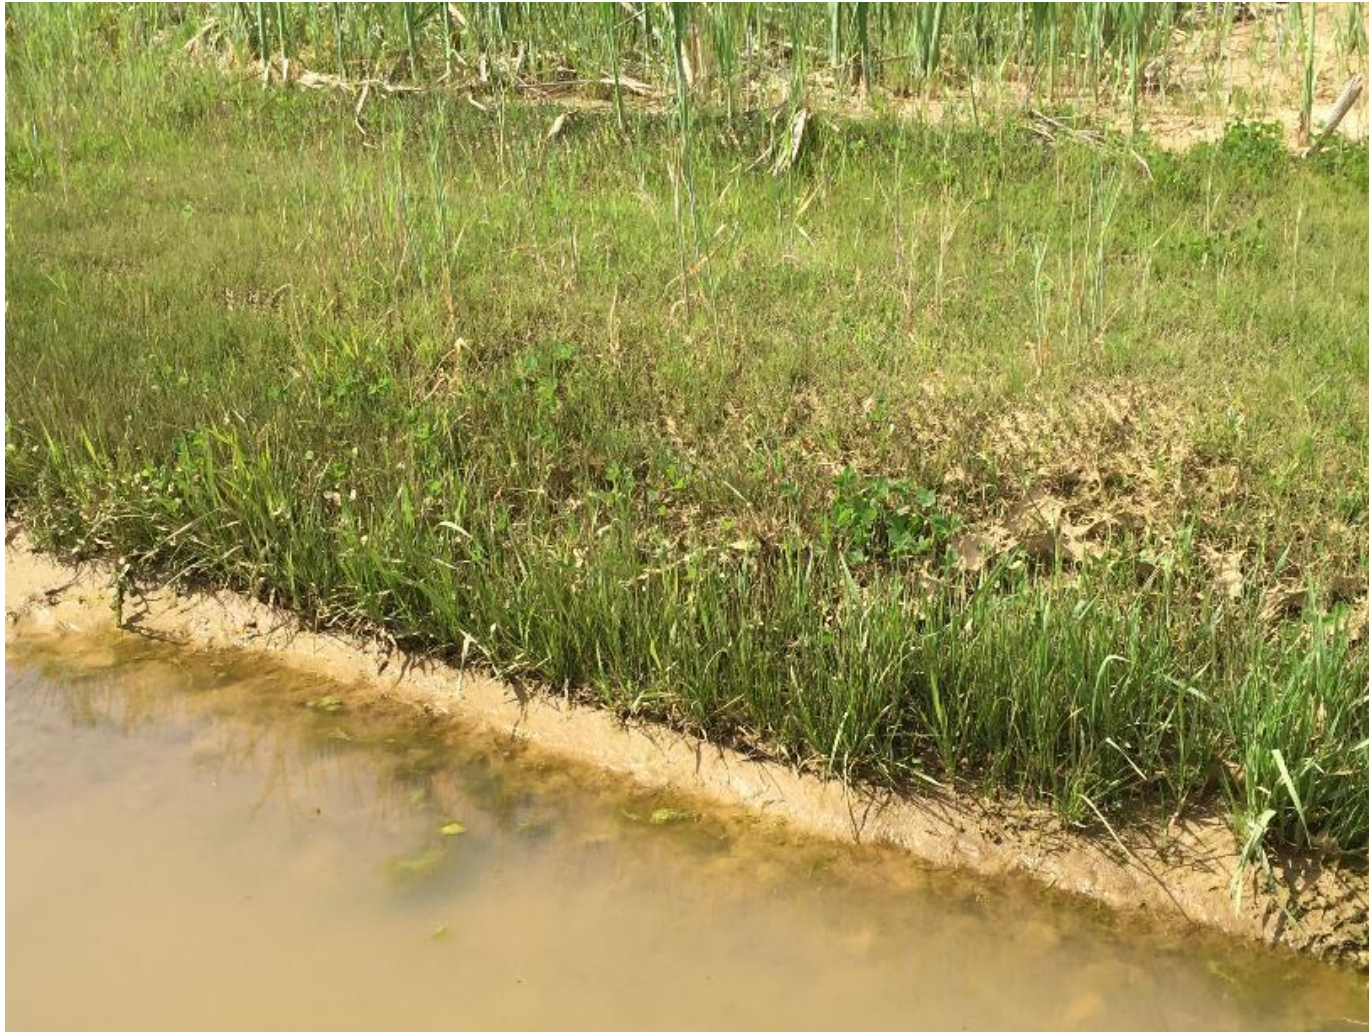
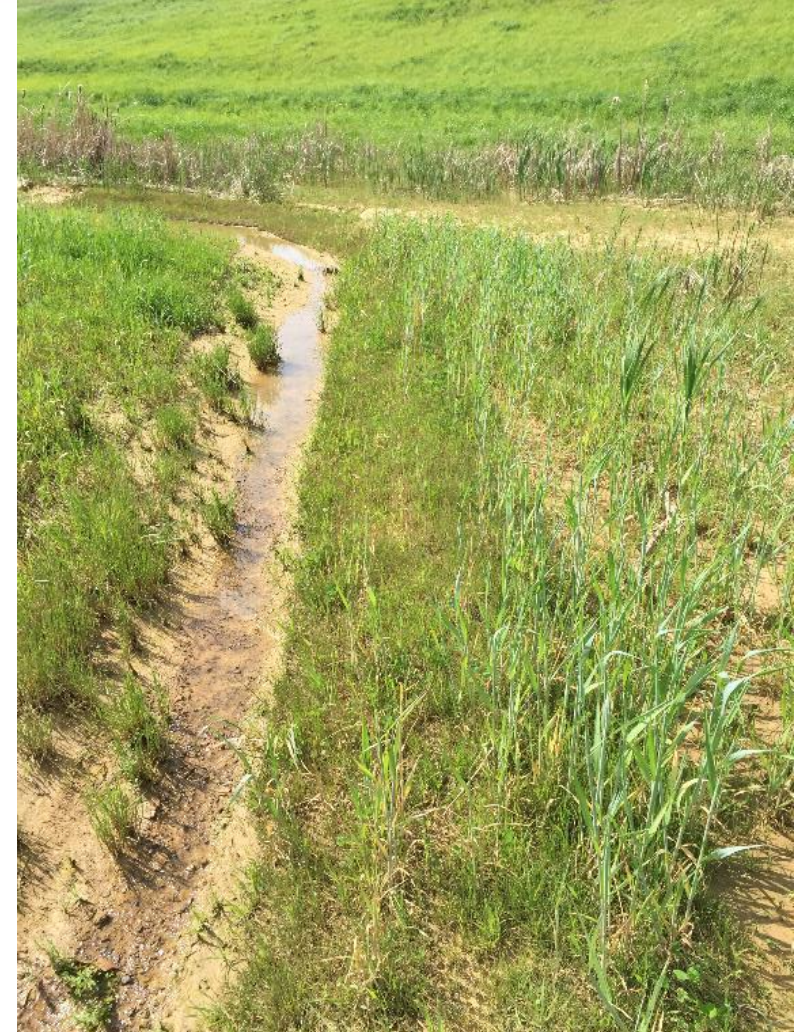
April 30, note the distinct lines formed by the edges of the ShearForce10 mats along the shoreline

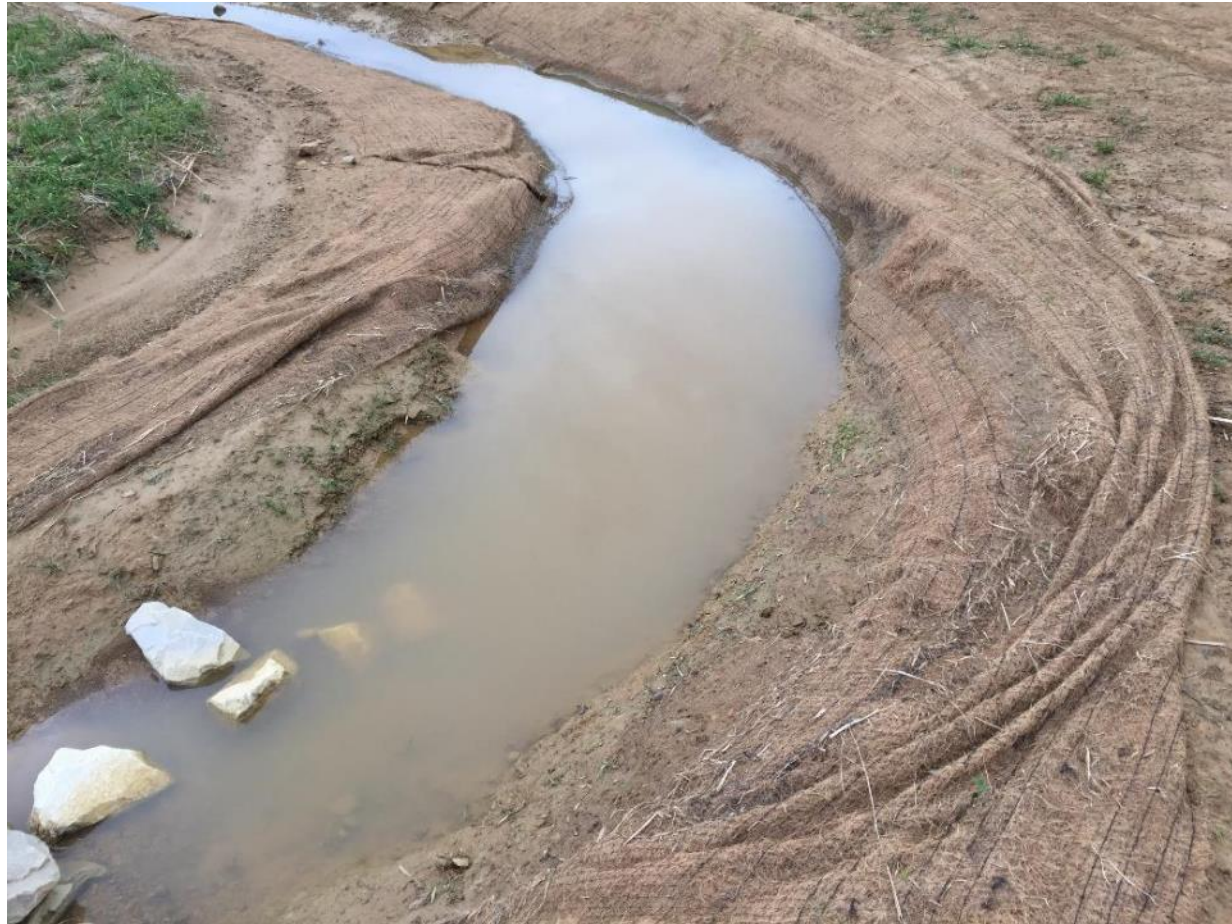
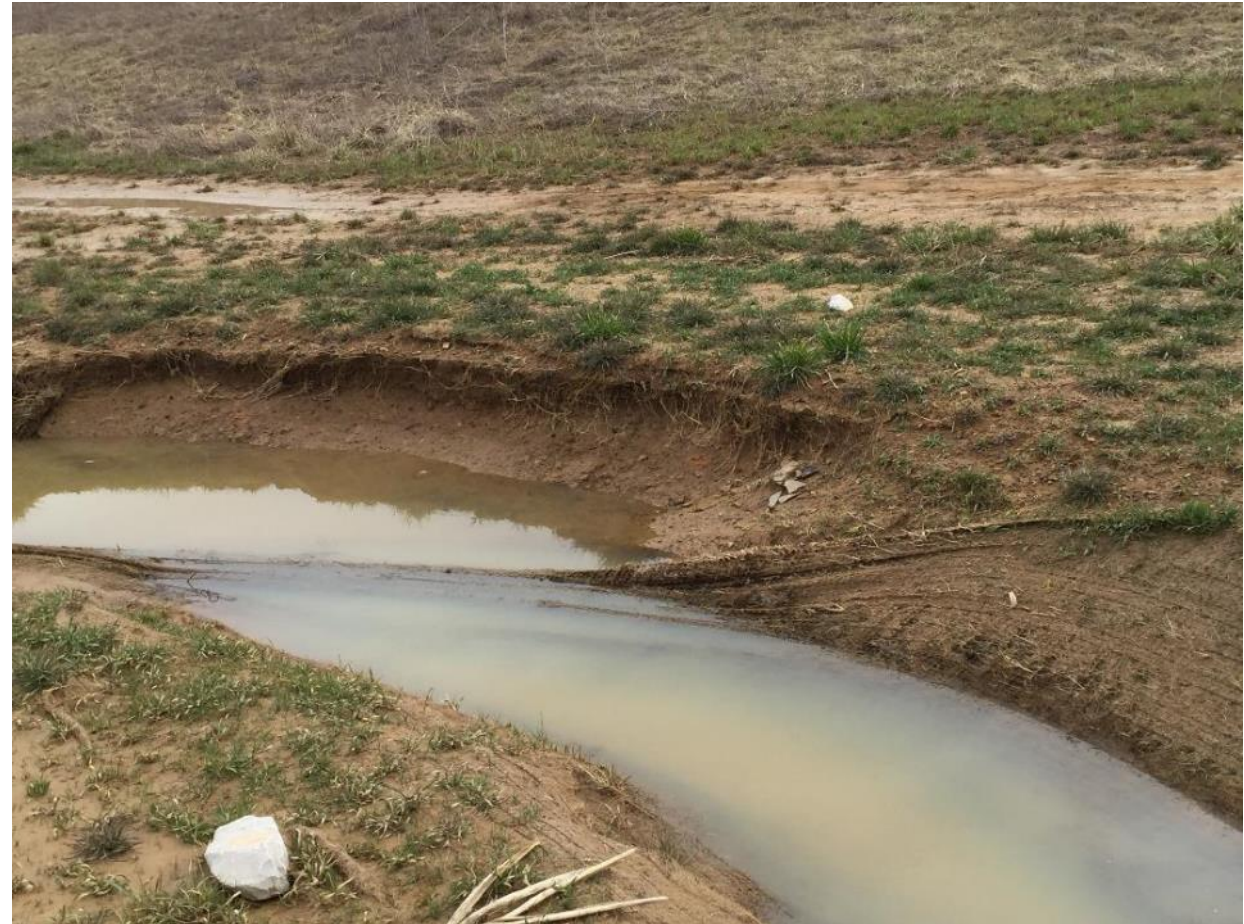
Coconut Erosion Control Blanket On Peabody Coal Streambanks

The two inch rainfall that occurred one week after installation severely damaged coconut erosion control blankets installed on other sections of the stream channel and initiated significant bank erosion

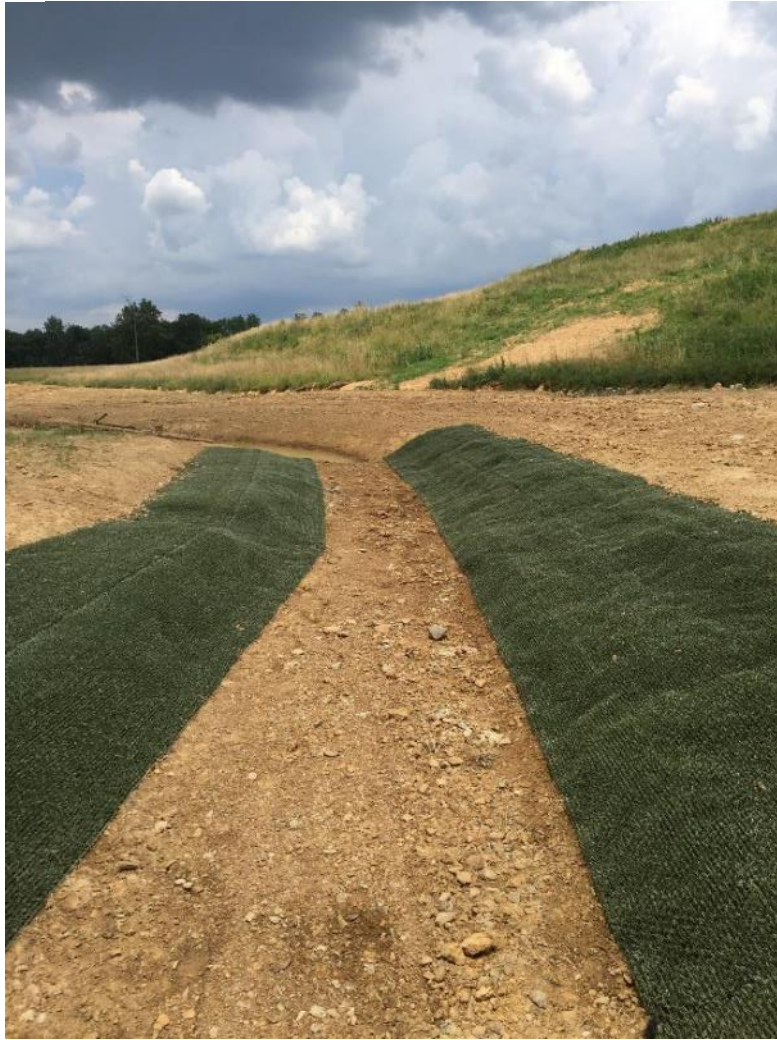
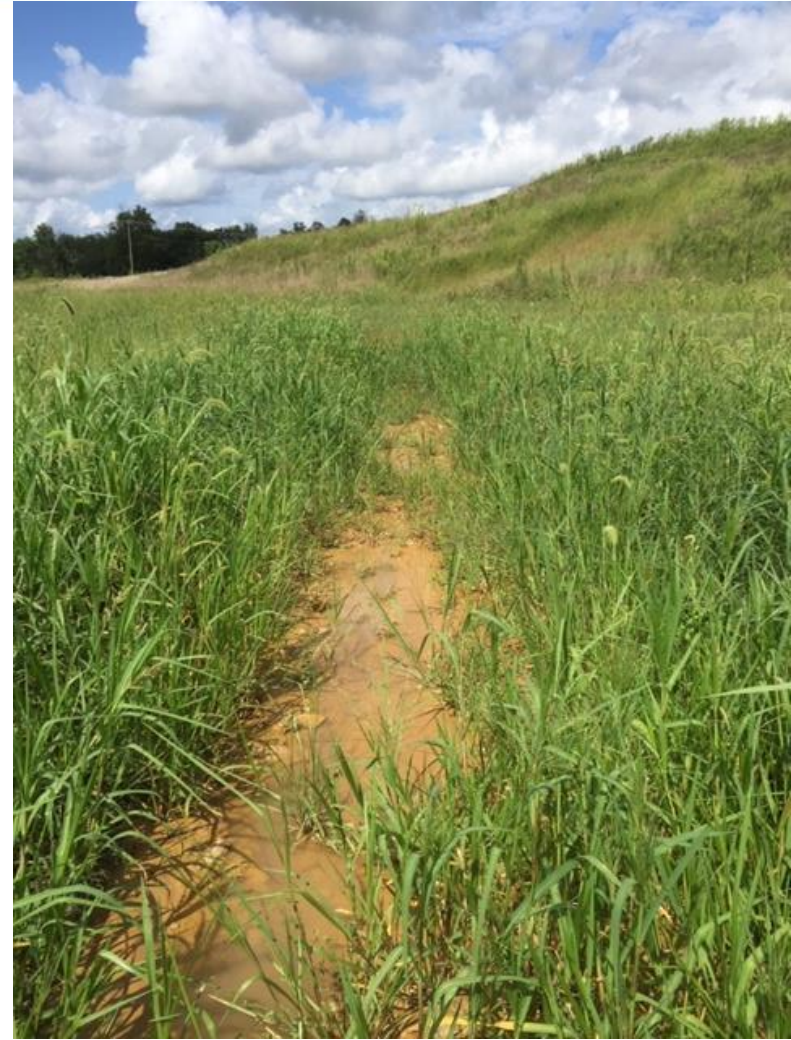
Peabody Coal Streambank Installation

ShearForce10 just after installation on June 28, 2019 (left). 2 months after installation, vegetation developing nicely (right).
